**NUMBER:** 05-88-21R

# **SERVICE BULLETIN**

SUBJECT: Front Stabilizer Bushing- Design Change

Knocking / Squeaking Sound

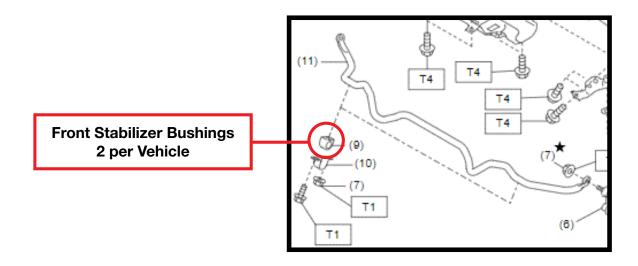
This bulletin announces a design change made to the front stabilizer bushings. The bushing material has been enhanced to address knocking / squeaking sounds when driving on rough roads during low ambient temperatures. If confirmed under the described driving conditions, the bushings shown in the illustration below should be replaced.

The service procedures for front stabilizer bushing replacement remain unchanged. Always refer to the applicable Service Manual and review the full requirements of the repair being performed. The Service Manual procedures contain information critical to performing an effective repair the first time, every time. This includes but is not limited to important SAFETY precautions, proper inspection criteria, necessary special tools, required processes and related one-time-use parts needed for a complete and lasting repair.

Refer to the applicable Subaru Service Manual: <u>Suspension > FRONT SUSPENSION > Stabilizer > STABILIZER BUSHING</u>
