## SERVICE BULLETIN

**APPLICABILITY:** 2019-22MY Forester  
2022MY Impreza  
2022MY Crosstrek

**NUMBER:** 12-242-22

**SUBJECT:** Roof Panel Molding – Excessive Gap

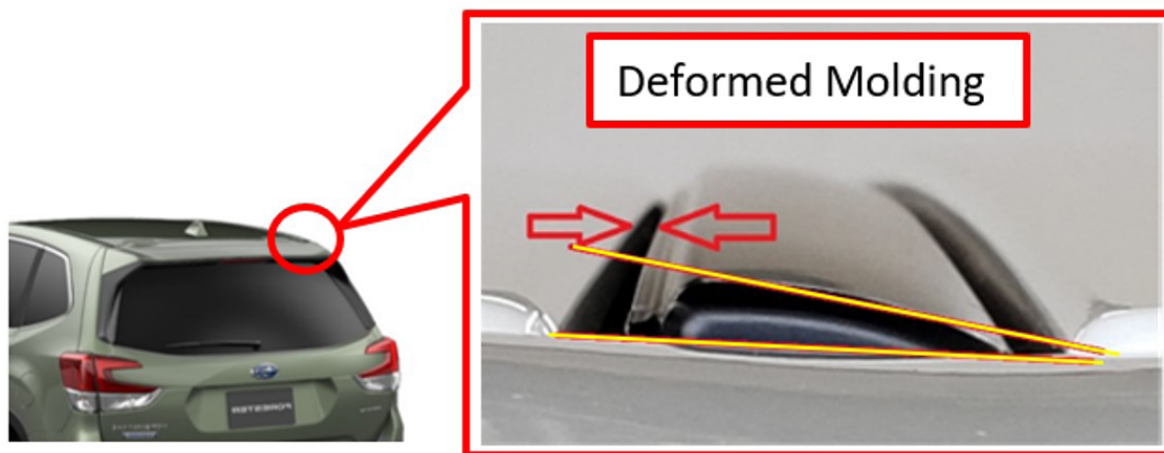
This bulletin announces the shape design change made to the roof molding fasteners to help prevent any deformation of the molding. A customer may experience an excessive gap between the roof molding and the roof panel. The new fasteners have an enhanced shape to help maintain a flat fitment of the roof molding. If this roof molding with excessive gap is reported, replace the affected fasteners with the newly redesigned parts.

**NOTE:** When deformation is present, it can be seen from all sides.

- All fasteners on **BOTH** sides **MUST** be replaced.
- Refer to the applicable Service Manual and review: General Description > Repair Contents > Action required before & after Battery Disconnect. Additionally, record any stored seat position(s) before proceeding. Relearn any seat position memory after work is complete. If the power rear gate (PRG) height has been customized, that position must also be noted and relearned.
- Whenever reconnecting the ground cable terminal to the battery sensor, torque to 7.5Nm (5.5ft.-lbs. or 66inch-lbs.) while supporting the sensor with the other hand as outlined in the applicable Service Manual under: STARTING/CHARGING SYSTEMS > Battery Sensor.
