FORWARD SENSING CAMERA (FSC) WARNING MESSAGES

Service Alert No.: SA-066/22

Last Issued : 10/12/2022

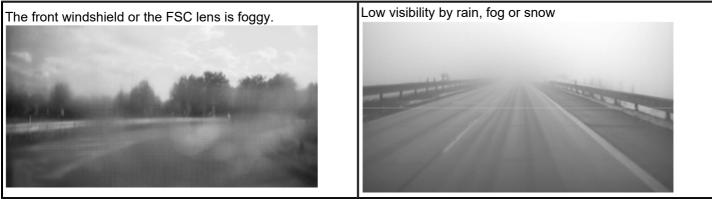
- 1. At night, when there is NO artificial lighting such as a traffic signal, street light or reflective surfaces.
- 2. When direct or reflected sunlight makes forward visibility difficult (Backlight).
- 3. When it's hard to see the traffic lane due to a wet or snow covered road reflecting lights.
- 4. When visibility is poor in front of the vehicle due to fog.
- 5. When driving on a road without markings.
- 6. In conditions where the windshield fogs easily.

Examples of driving under adverse conditions:
