Service Alert

Subject: MAZDA RADAR CRUISE CONTROL (MRCC) DISABLED UNDER 20 MPH	Service Alert No.: SA-067/22
	Last Issued : 10/12/2022

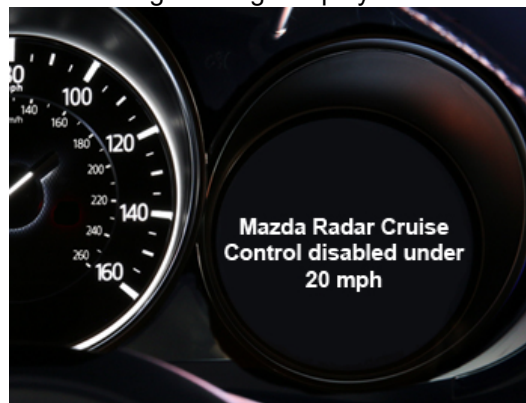
Some customers may complain about the following message displayed in the Multi-Information Display:

In the following cases, the MRCC with Stop & Go function system is canceled when the vehicle is traveling at 19 mph (30 km/h) or less:
