Subject: ACCUMULATION OF COOLANT AROUND WATER PIPE	Bulletin No.: 01-012/22
	Last Issued : 10/06/2022

2016-2022 Mazda2 (Mexico/Puerto Rico)

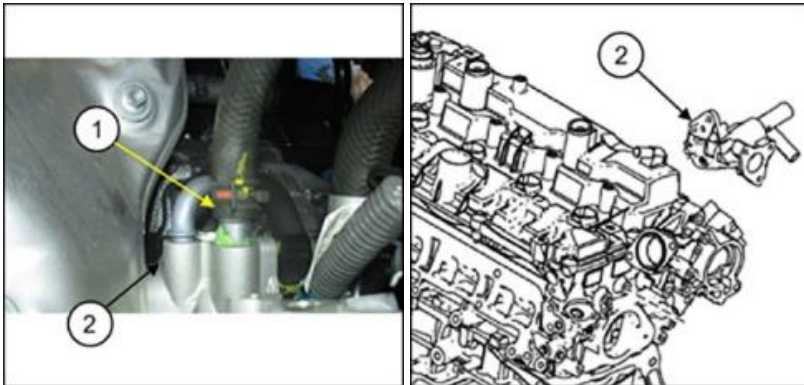
Some vehicles may exhibit accumulation of dried coolant (1) around the water pipe (2). This is caused by a gap between the housing and pipe due to a press fitting during the manufacturing process. The accumulated coolant is solidified and plugs the gap in high temperature environment and the seepage is stopped and does not progress. This is normal and does not require a part replacement, clean off the dried coolant from around the pipe with a wire brush.
