# Technical Service Bulletin

<b>Subject:</b>  CHECK ENGINE LIGHT ON WITH DTC P0126:00	<b>Bulletin No.:</b> 01-013/22
	<b>Last Issued :</b> 10/19/2022

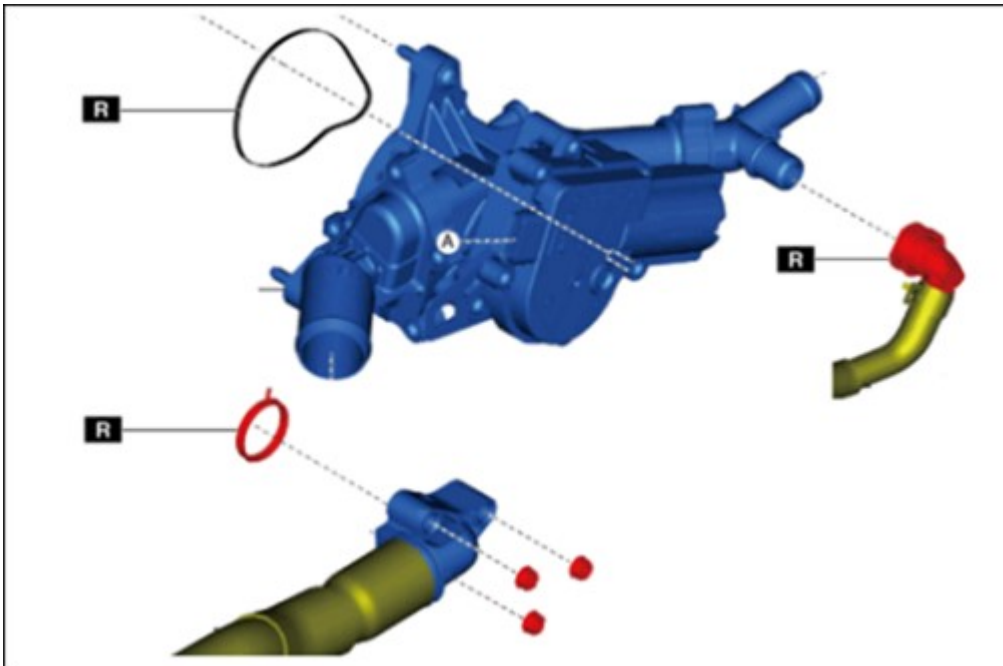
**Replacement Part Locations**

- O-ring
- Gasket
- Connector

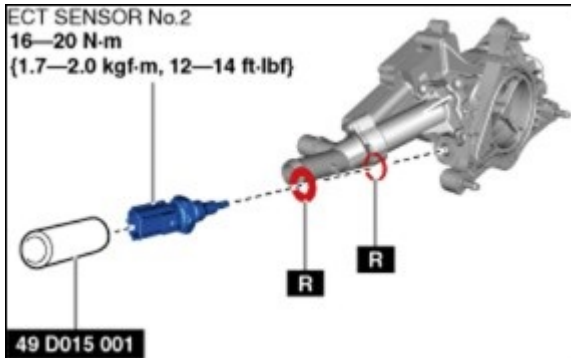
- O-ring and washer for ECT sensor No.2

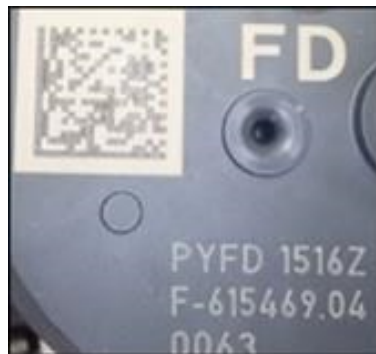
**NOTE:** Since the modification has been implemented during the production of the part number without a suffix, it is necessary to check the suffix and the production date code of the obtained part.

- If available part is PYFD-15-16ZA or with later suffix, the following procedure is not necessary.
1. With a smart phone, scan the two dimensional code on the water control valve.
  2. The code consists of three blocks of codes where the sample picture is read as PYFD1516Z 171115 0000063 and the second block of the code is the production date in YYMMDD format.
- If the second block of the code is 201116 or greater (meaning November 16, 2020 or later), the coolant control valve is modified.
