Technical Service Bulletin

Subject: POOR A/C PERFORMANCE DUE TO LEAKING REFRIGERANT FROM THE AIR CONDITIONER CONDENSER OR PIPE	Bulletin No.: 07-003/22
	Last Issued : 10/20/2022

2016-2022 CX-9

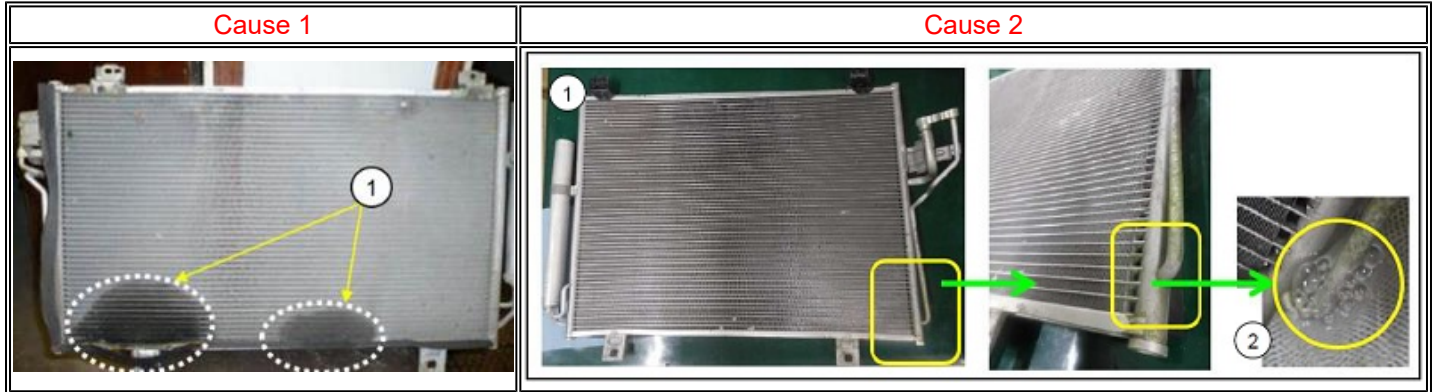
Cause 1: [For 2016-2022 CX-9 with VINS lower than JM3TC*****617612 (produced before April 7, 2022)] The condenser is corroded causing leakage of the A/C refrigerant. To eliminate this concern, the anti-corrosion performance of the condenser tube has been improved.

Cause 2: [For all 2016-2022 CX-9] The low-temperature side outlet pipe leading to the evaporator of the air conditioner condenser has deteriorated because the structure around the outlet pipe on the low-temperature side of the air conditioner condenser allows mud and salt water to adhere easily. There is no mass production change, but an improved condenser was designed as needed.

1. Verify the customer concern.
2. [For Cause 1] Check for A/C refrigerant leak as shown in the area (1) without stone chipping damage.
[For Cause 2] Use a gas leak tester or a fluorescent agent-detecting UV black light to check if there is a leak from the condenser (1) from the area shown (2) in the figure.

- If gas leaks from one of these areas, replace the condenser with a modified one.
 - 2016-2020 CX-9 (CONDENSOR REMOVAL/INSTALLATION)
 - 2021-2022 CX-9 (CONDENSOR REMOVAL/INSTALLATION)
- If there is no gas leak from these areas, troubleshoot the poor A/C performance according to the instructions on MGSS.
