Technical Service Bulletin

Subject: FRONT DOOR INTERFERES WITH REAR DOOR GARNISH (MAZDA3 4-DOOR SEDAN)	Bulletin No.: 09-028/22
	Last Issued : 10/05/2022

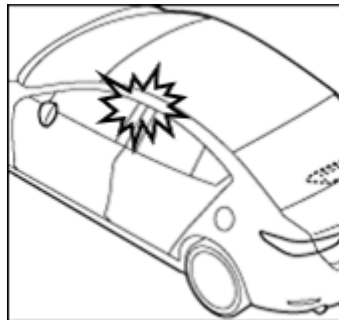
Some vehicles may exhibit the glass run channel of the front door interfering with the rear door garnish.

This is caused by the front door glass run channel not being fixed strongly enough to the door for the following situations where the cycles of door operation may result in interference and lead to damage on the rear door garnish.

- When the front door glass is closed, the glass run channel may be forced to move to the B pillar side.
- During very hot weather, the glass run channel may expand to the B pillar side.

To eliminate this concern, the design of the front door glass run channel has been changed to be fixed stronger to the door.

1. Verify the customer concern.
2. Replace the front door glass run-channels with modified ones, regardless if the other side is damaged or not, following the instructions on MGSS (FRONT DOOR GLASS RUN-CHANNEL REMOVAL/INSTALLATION).

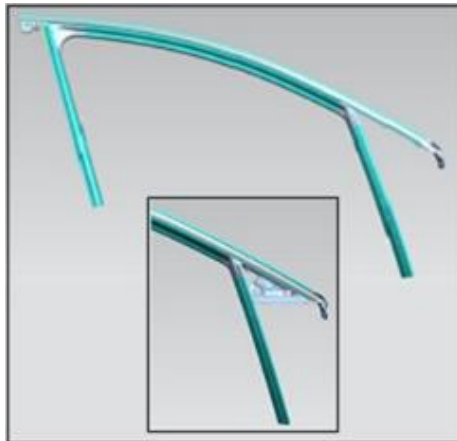
- The outer beltline molding does not need to be removed/replaced for this repair, even though the procedure on MGSS instructs to do so.
- The service hole cover No.1 does not need to be replaced with new one, even though the procedure on MGSS instruct to do so.
- It is highly recommended to remove all broken clips from the sails and door garnishes before installing any new parts on the vehicle.
- Use a plastic scraper and some adhesive remover when cleaning the double-sided tape residue from the pillars.
- Depending on the parts level (suffix M or later), the corner bracket is integrated to the new glass run-channel. If the obtained part is one of these, remove the old corner bracket from the vehicle.

- If the vehicle is NOT equipped with accessory side window deflectors, select job type A, B or C, depending on the damage on the rear door garnish.
- If the vehicle is equipped with accessory side window deflectors, select job type D.
