Technical Information Service 72/20 ENU WLD5

WLD5 - Replacing Hose for Positive Crankcase Ventilation (Workshop Campaign)

Vehicle Type: Cayenne (9YA)

Subject: Positive crankcase ventilation hose

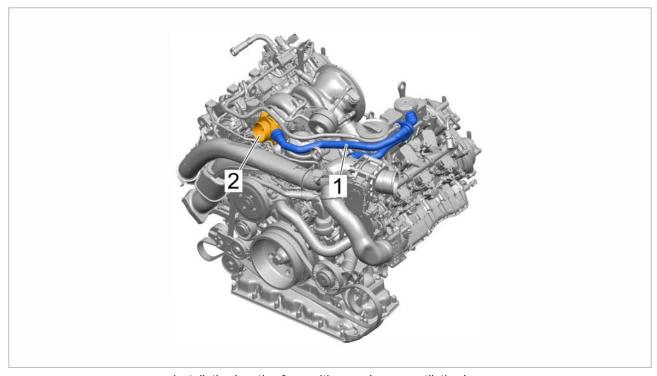
Information: A part-load valve was installed in the hose for crankcase ventilation on the affected vehicles

which has a sealing washer that does not meet the required specifications and could possibly

crack when the crankcase pressure rises.

Consequently, small amounts of engine oil can leak from the oil filler cover into the adjacent engine compartment, resulting in a reduced engine oil level over time. The driver is alerted by an appropriate

Installation location for positive crankcase ventilation hose.

- Positive crankcase ventilation hose
- 2 Intake manifold

Replace positive crankcase ventilation hose with intake manifold.

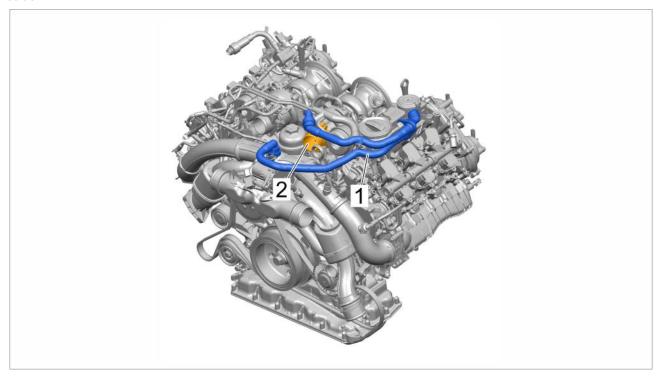
Information: A part-load valve was installed in the hose for crankcase ventilation on the affected vehicles

which has a sealing washer that does not meet the required specifications and could possibly

crack when the crankcase pressure rises.

Consequently, small amounts of engine oil can leak from the oil filler cover into the adjacent engine compartment, resulting in a reduced engine oil level over time. The driver is alerted by an appropriate

Installation location for positive crankcase ventilation hose.

- Positive crankcase ventilation hose
- 2 Intake manifold

Replace positive crankcase ventilation hose with intake manifold.
