## Flush-Mounted Door Handle Jams When Pulled Out

Topic number	LI72.10-P-074316
Version	3
Function group	72.10 - Front door
Date	10/31/22
Validity	MODEL 297 with CODE 889 up to manufacturing date 24 January 2022 MODEL 223 with CODE 889 up to manufacturing date 24 January 2022 MODEL 295 with CODE 889 up to manufacturing date 15 July 2022
Reason for change	Validity extended to Model Series V295

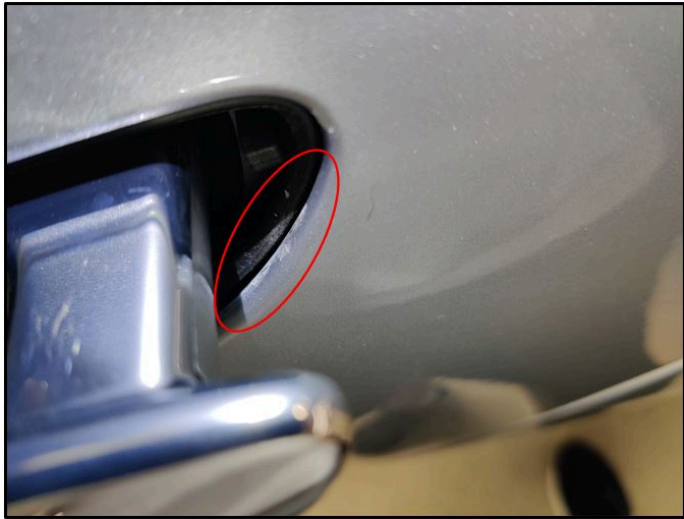
Attachments	
File	Description
<a href="#">Bild 1.JPG</a>	Picture 1

- The flush-mounted door handle could jam when it is pulled out and may move in a jerky manner when doing so.
- In the area of the paneling section of the door, paint damage could be present (picture 1) and/or an abrasion point could be present at the door handle (picture 2).

3.) Paint over paint damage at door paneling (see picture 1) according to manufacturer specifications, using spot repair procedure if necessary.
