Front bumper/facia fit above headlamps

Topic number	LI88.20-P-071570
Version	3
Function group	88.20 - Bumpers
Date	10/7/22
Validity	BR290
Reason for change	Updated adhesive part number
Reason for block	old part number

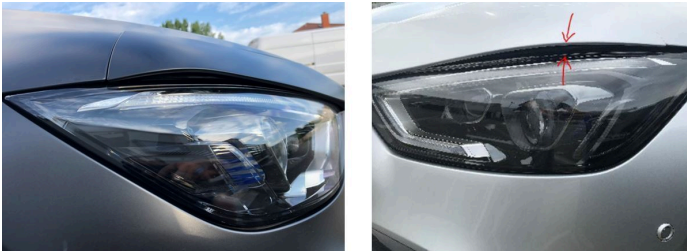
Attachments	
File	Description
Beanstandung.JPG

Bulging of front bumper above headlamps (see attachment). Function of headlights not blocked or impaired.

Bulging on bumper above the headlamp

Bonding between bracket and bumper may be separating.

Detach front bumper and check whether the brackets can be easily removed without damaging or deforming the bumper.

A) If the brackets can be easily removed without damaging or deforming the bumper --> Carry out the following rework:

1. Clean the inner side of the bumper and the new brackets and then apply primer.
2. Attach 3M tape as per Attachment 1.
3. Apply additional beads of adhesive (A 009 989 85 71 - Sikaflex ® 254 plus corresponding primer A009 989 75 71 - Sikaflex ® 209 Prime) between and next to the 3M tape, as per Attachment 2.
4. Bond the brackets to the inner side of the bumper and allow to cure sufficiently.

B) If the brackets cannot be removed without damaging or deforming the bumper (bond too strong) --> Perform procedure A, and replace the bumper.
