Location: Body Exterior

Topic: Fuel Filler and PHEV Socket Covers Flush Condition

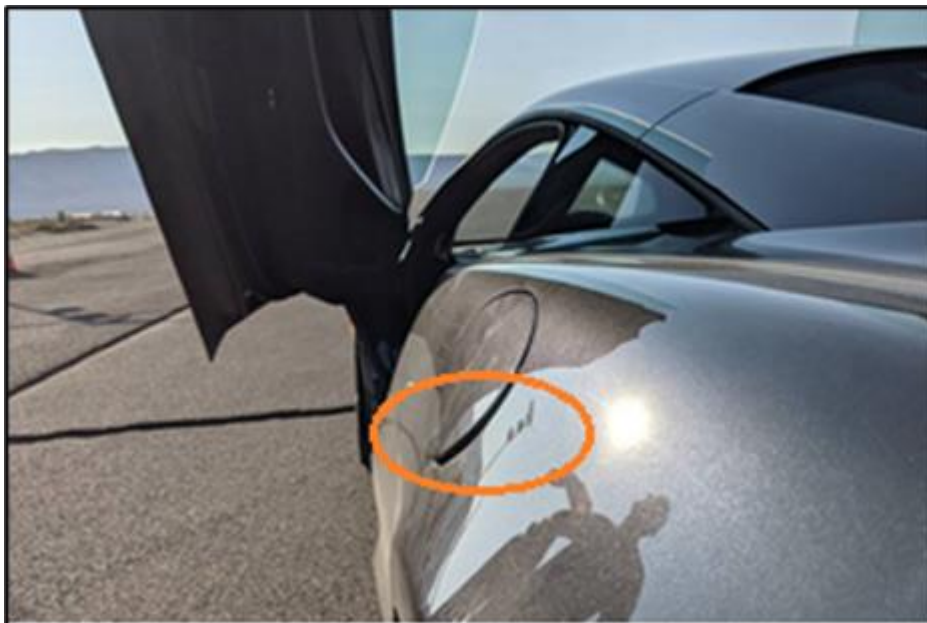
- PHEV Socket Cover (LH) = rear lower edge
- Fuel Filler Cover (RH) = rear upper edge

Image 1: PHEV Socket Cover (LH) – Rear Lower Edge Over Flush

- Follow SIS instructions to gain access to the fuel filler bowl or the PHEV socket bowl and loosen the 4 bowl retaining fixings
- Add shims to the local riv-stud where the deformed bowl over-flushness occurs. The addition of the shims will reduce over-flushness of the bowl to bodyside
- In most instances 2 shims (1mm total thickness) will suffice. Do not use any more than 3 shims added together (no more than 1.5mm total thickness)
- After fitting the shims(s) lightly press a finger on the edge of the bowl surrounding seal around the bottom of the bowl to verify there is seal engagement with the clam lip
- If the edge of the bowl surrounding seal falls inside the clam aperture reduce the number of shims to 1 (0.5mm total thickness) to ensure correct fitment of the seal
- Re-tighten the bowl fixings with the shims installed
- Re-install all remaining components in the reverse order

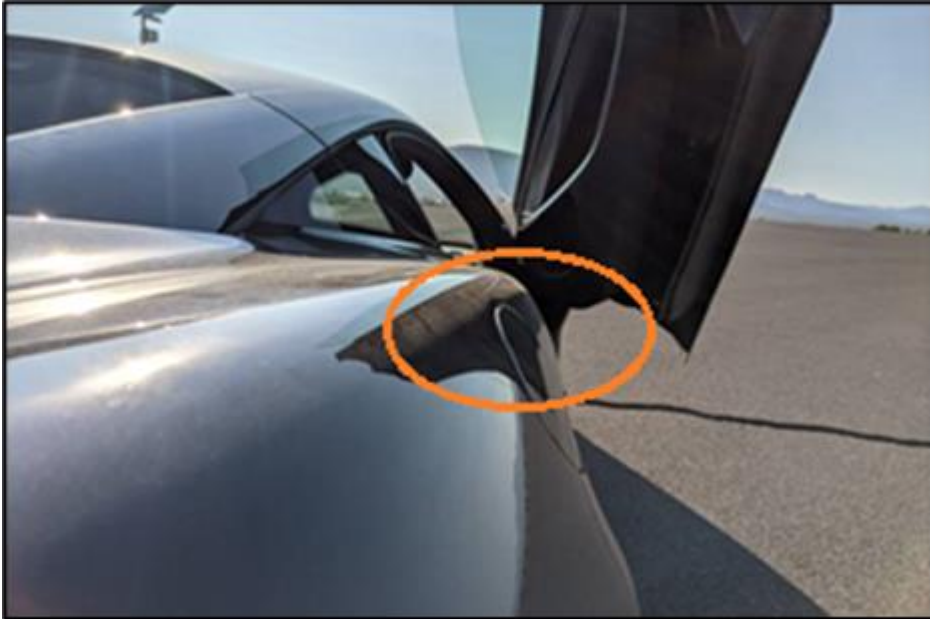
Image 2: Fuel Filler Cover (RH) – Rear Upper Edge Over Flush

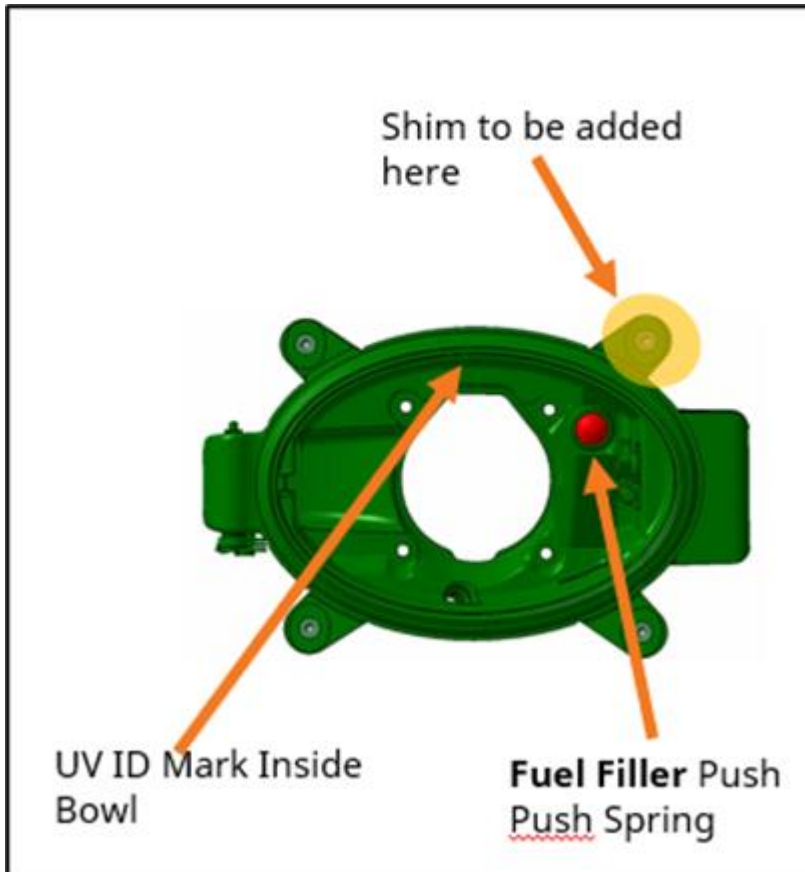
Image 3: Shim Location – Fuel Filler Bowl

13AA452CP - SHIM 0.5MM

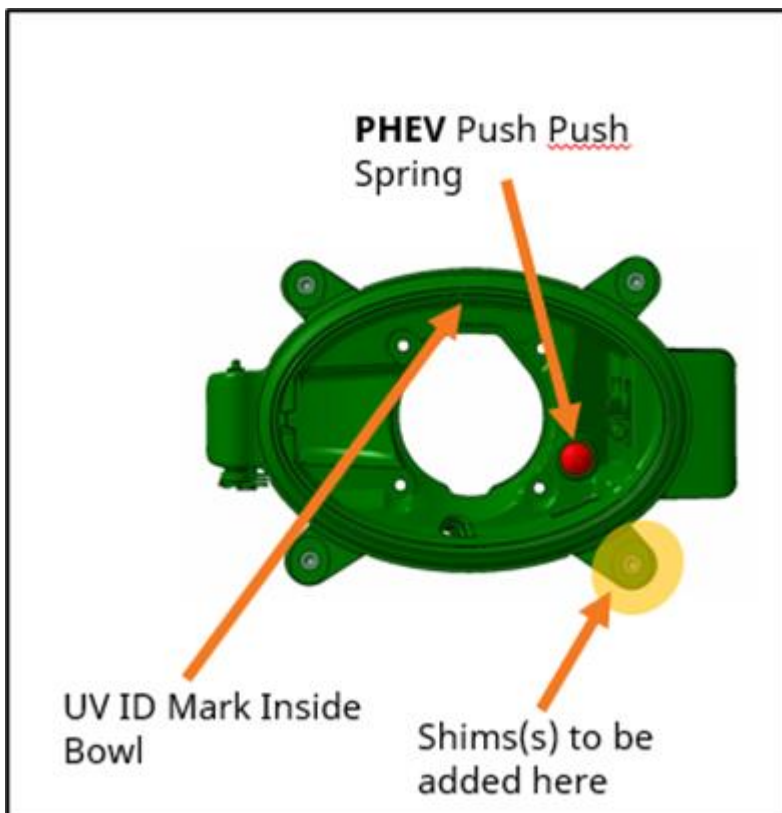
Image 4: Shim Location - PHEV Socket Bowl

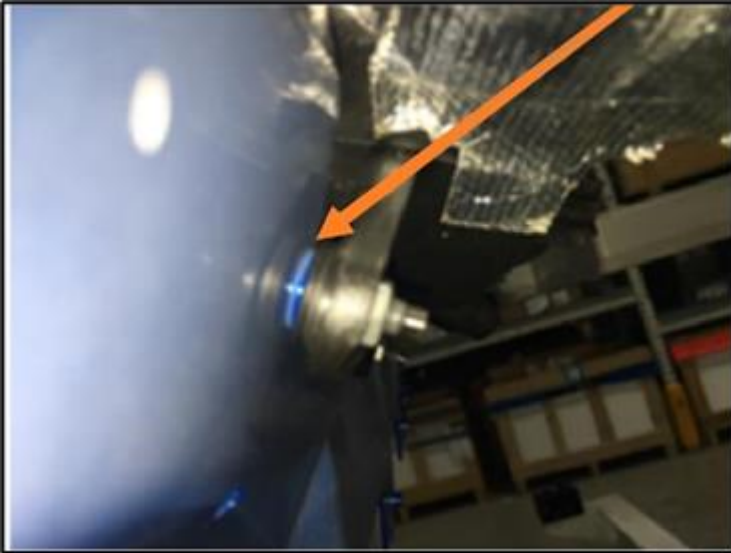
Image 5: Shim in fitted position

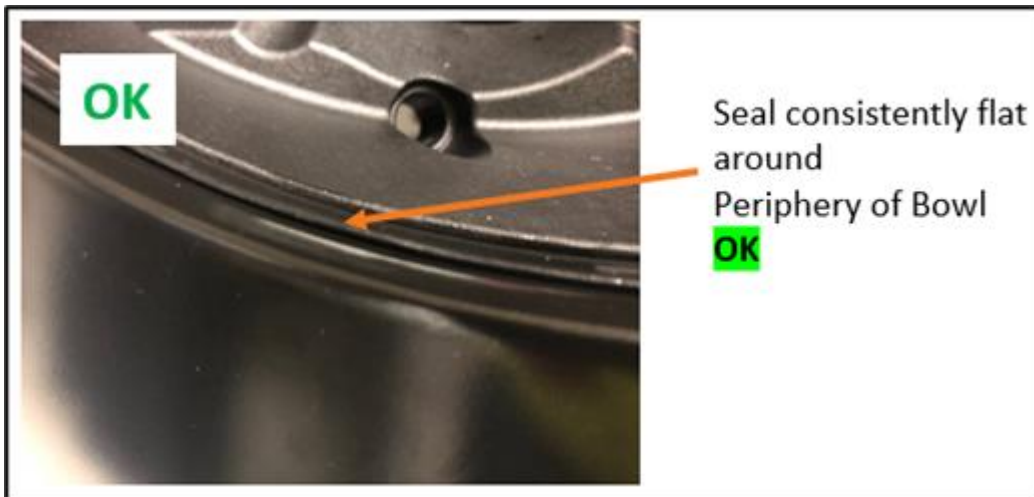
Image 6: Correct Bowl Surrounding Seal Engagement

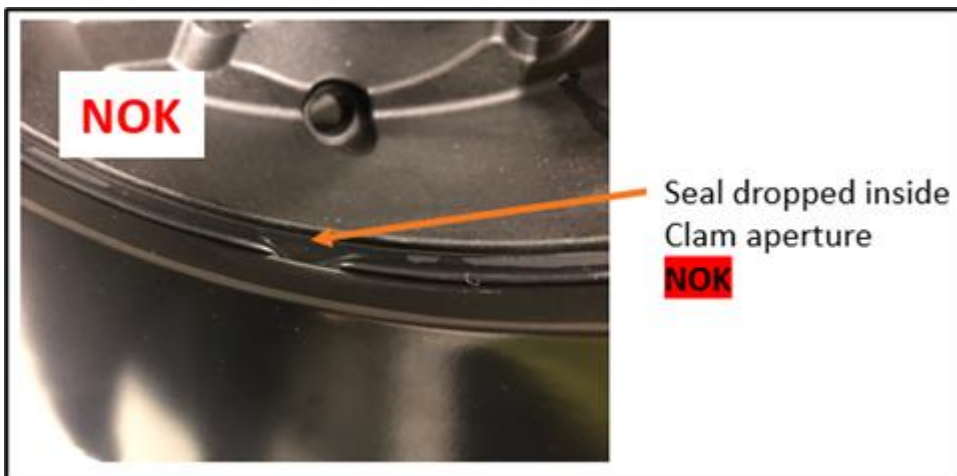
Image 7: Incorrect Bowl Surrounding Seal Engagement
