McLaren Artura Body Harness Rework

Bulletin type:	Service Campaign
Reference number:	N/A
Campaign reference:	SCB 16 M 001
Attention:	Retailer Aftersales Managers, Retailer Service Managers, Retailer Service Advisors, Retailer Technicians
Affected vehicles:	McLaren Artura
Situation:	Addition of spacer bushes and felt tape to the body harness and carbon tub
Procedure:	Action affected vehicles prior to handover. Please refer to the information outlined in this document to complete the required work
Date:	07 October 2022

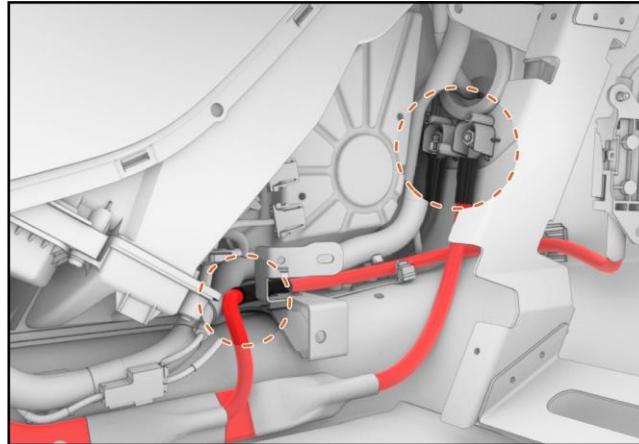
Figure 1: Location of rework area

Through continuous product quality monitoring, McLaren Automotive has identified that on certain McLaren Artura vehicles that a body harness enhancement is required in the area behind the HVAC shroud of the tunnel console.

To carry out the required rework, two split spacer bushes are required to be fitted around a specific cable of the body harness and a felt tape applied to the carbon tub. Document SCB 16 M 001 WI (attached with this bulletin), contains the relevant work instructions and care points to ensure the work is carried out to bring the vehicle up to the current manufacturing standard.
