# McLaren Speedtail – Remaining Parking Days Display Incorrect

<b>Bulletin type:</b>	Service Campaign
<b>Reference number:</b>	N/A
<b>Campaign reference:</b>	SCB 23 M 006
<b>Attention:</b>	Retailer Aftersales Managers, Retailer Service Managers, Retailer Service Advisors, Retailer Technicians
<b>Affected vehicles:</b>	McLaren Speedtail
<b>Situation:</b>	The remaining parking days displayed in the instrument cluster are incorrect
<b>Procedure:</b>	Action affected vehicles during next Retailer visit. Please refer to the information outlined in this document to complete the required work
<b>Date:</b>	06 October 2022

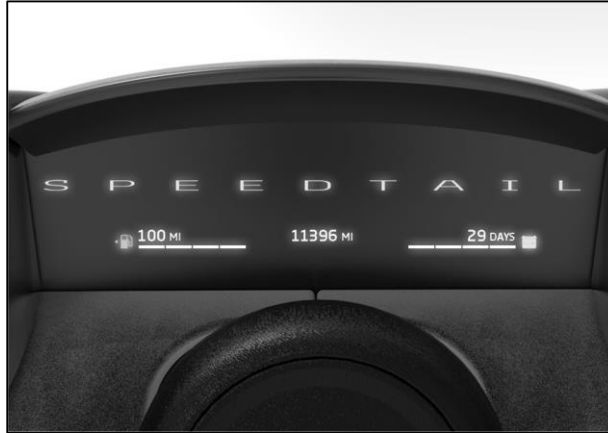
Figure 1 Example of remaining parking days display

Through continuous product quality monitoring, it has been identified that on McLaren Speedtail vehicles the number of parking days remaining displayed in the instrument cluster is incorrect. Therefore, a McLaren Diagnostic System (MDS) procedure has been released in order to re-configure this feature.

- Execute Body Controller (BC) MDS Quiescent Current Configuration Sequence:

- Execute Instrument Cluster (IC) MDS Coding
