# Customer Satisfaction Program

## N212354521 Heated Vented Seats Retrofit Due to Chip Shortage - Front Seats Only

**Revision:** 02

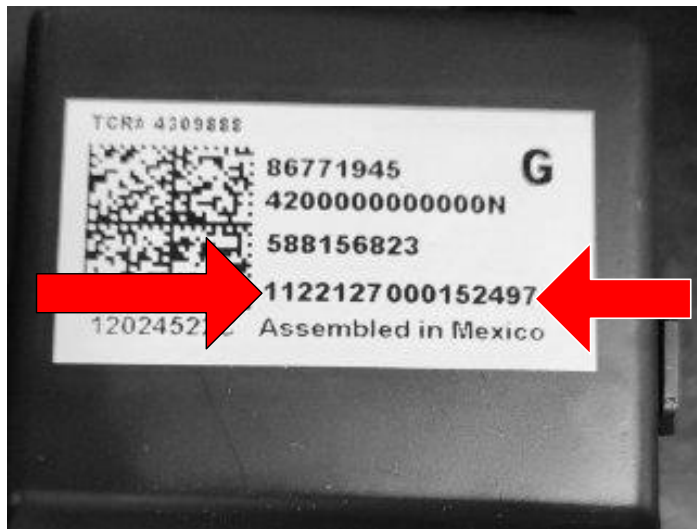
6098078

Record the serial number on the seat heater vent control module label.
