Engine 'knocking' noise on start up after a new service engine has been fitted- AJ20-D4

17-19MY F-Pace , XF, XE , RR Velar

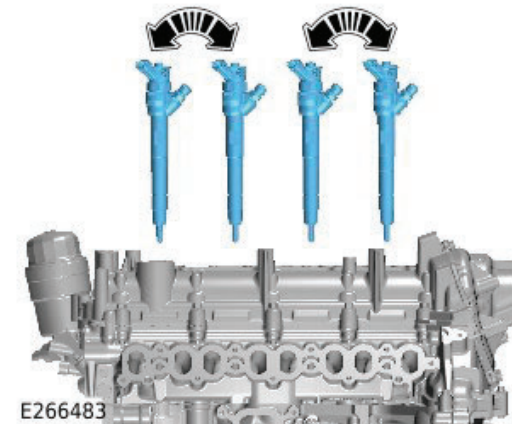
- Engine 'knocking' noise on start up after a new AJ20-D4 service engine has been fitted.

- Repair process on TOPIx for long/stripped engine assembly is not being adhered to, specifically regarding the installation and programming of the fuel injectors.
- They must be fitted to the adjacent cylinder as shown in the TOPIx procedure (303-01A) ,
- This allows the PCM to reset the fuelling adaptations and will allow successful injector programming to take place (injector programming/resetting adaptations is required upon completion of the new engine installation as detailed in the TOPIx procedure).

Refer to SSM 75771 / SSM 75772
