SERVICE ACTION

Global Service Action
Number: N694

Subject: <h3>Windshield Water Leaks</h3>	Publication No.: N694
	Model: Discovery (LR)
	Model Year: 2018 - 2020
	Date of Issue: 11 October 2022
	Expiry Date: 31 October 2024

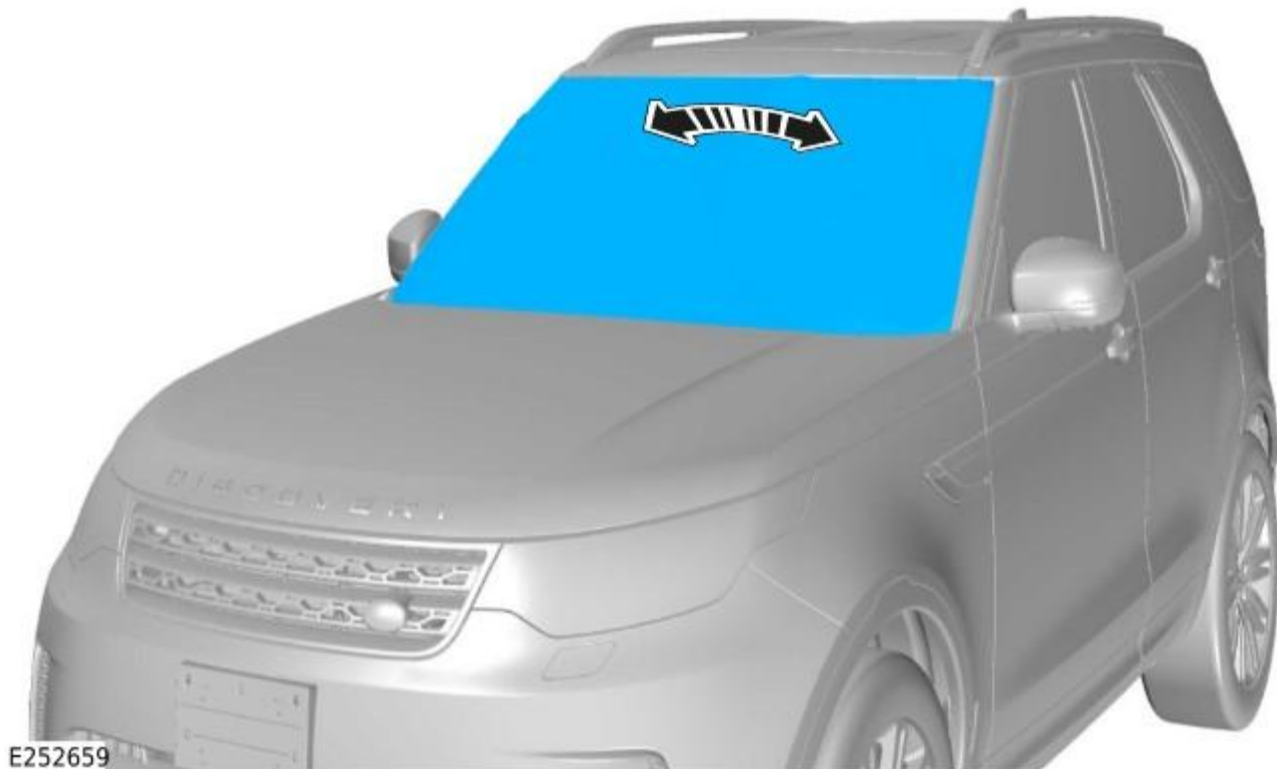
Complete a water test on the outside of the windshield, with a second technician inside the vehicle.

- Start in the lower section and spray the whole area, working left to right in stages.
- From inside the vehicle, apply gentle pressure by hand around the edge of the windshield.

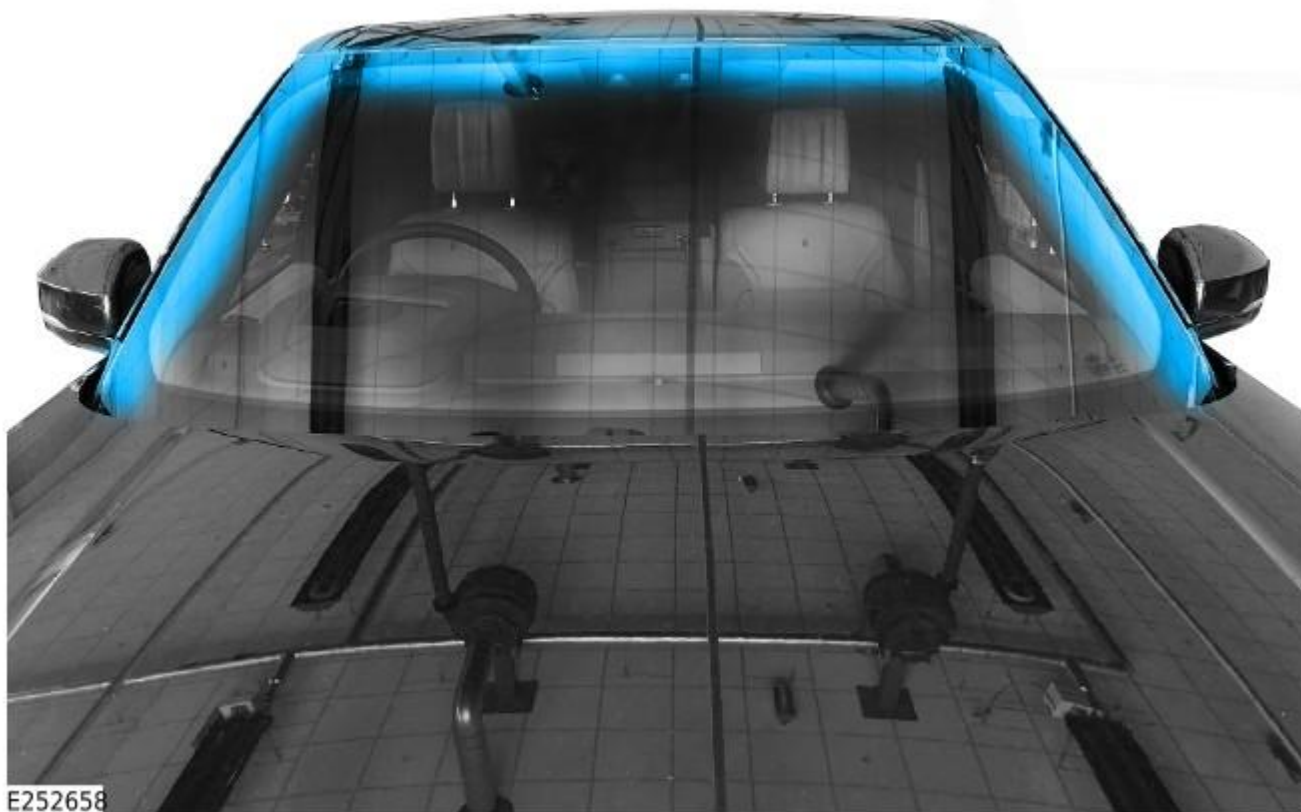
1. Apply soapy water around the edge of the windshield, as shown in the illustration.

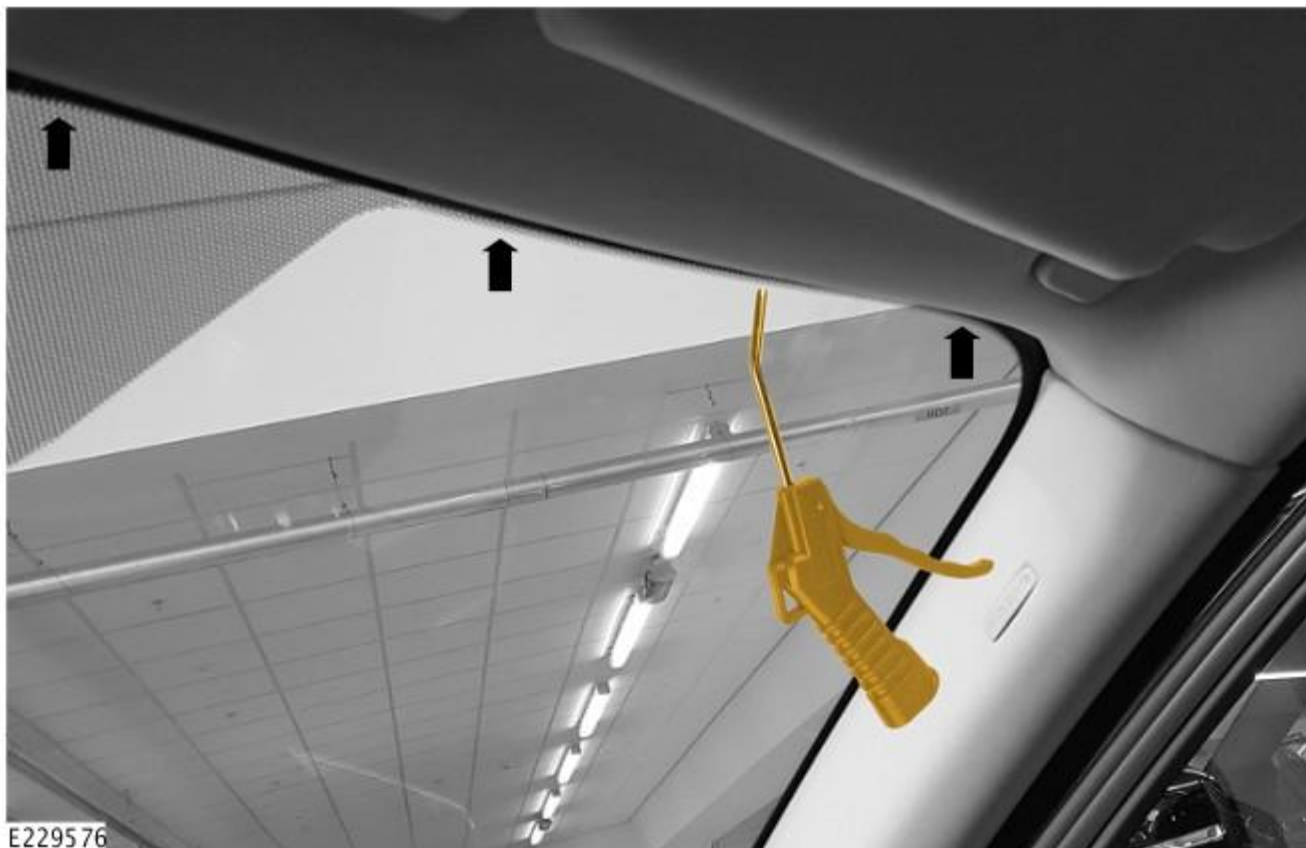
Using an air blower, blow compressed air around the inside edge of the windshield, as shown in the illustration.

- While continuing to blow air around the inside edge of the windshield, apply gentle pressure by hand around the inside edge of the windshield.
