STAR ONLINE PUBLICATION

Case Number: S2208000153

Symptom/Vehicle Issue: Tire Pressure Lamp Flashing, No Tire Pressures Displayed, "Tire Pressure Module (TPM) System Unavailable" Message Displayed on Cluster

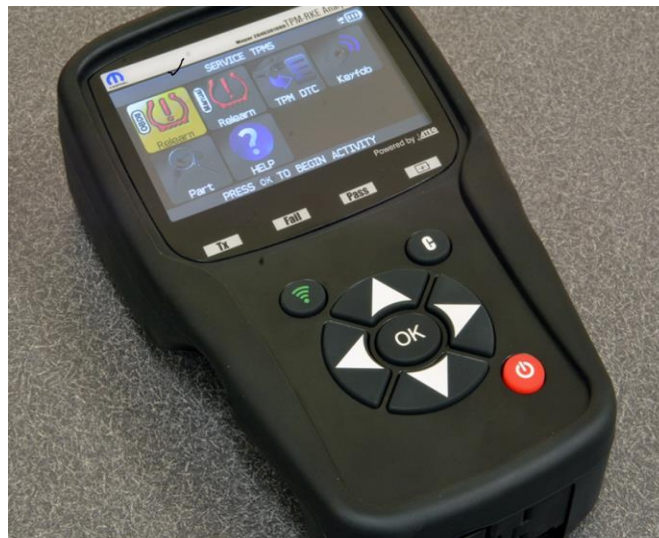
Discussion: When the localization sequence does not complete a total of 10 times consecutively for a single tire pressure placard vehicle or 1 time for a dual tire pressure placard vehicle (example - 60 psi front and 80 psi rear), the localization DTC C151D-00 is set. For dual pressure placard vehicles, see Service Library diagnostics and TPM reprogramming procedures as a guide.

Use TPM analyzer tool 2046301080 to perform the vin scan and OBD2 relearn if needed, review MT2109 September 2021 Master Tech and/or Warranty Newsletter Volume 6 Issue 11 – **V6I11: All Vehicles - Tire Pressure Sensors – Reprogramming tips**
