STAR ONLINE PUBLICATION

Case Number: S2223000066

Symptom/Vehicle Issue: Power Top Rattles Over Bumps And Rough Roads.

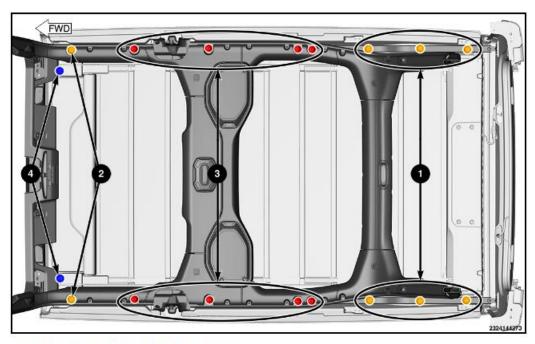
Fig 2 Screw locations.

Customer Complaint/Technician Observation: Vehicle is equipped with the STJ Sky One power top. Customer complaint of a rattle noise while driving coming from the roof area.

- 1 Rear Screws 70 mm (2.75 in) Screw Length
- 2 Front Door Opening Screws 70 mm (2.75 in) Screw Length
- 3 Middle Screws 103 mm (4 in) Screw Length
- 4 Front Header Screws 20 mm (0.75 in) Screw Length

Discussion: The power top system is fastened to the sport bar with 16 screws. Verify the torque for these fasteners is correct. Refer to the attached torque table and fastener location images below. If screw torque is not with in specification and is low replace the screw with updated fastener(s). 06513816AA for rear aperture and front screws (yellow locations in Fig 2). 06512210AA for the body screws (center red locations in Fig 2).
