STAR ONLINE PUBLICATION

Case Number: S1902000008 REV. A

Symptom/Vehicle Issue: Air Suspension Compressor Module Assembly Replacement.

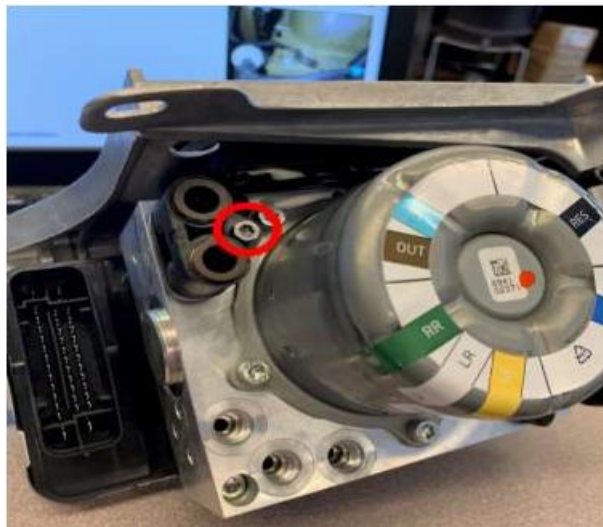
When servicing an Air Suspension Control Module assembly do not remove this fastener (circled in **RED** above). If the plastic fitting is removed from the compressor assembly an internal leak may occur resulting in nitrogen loss.

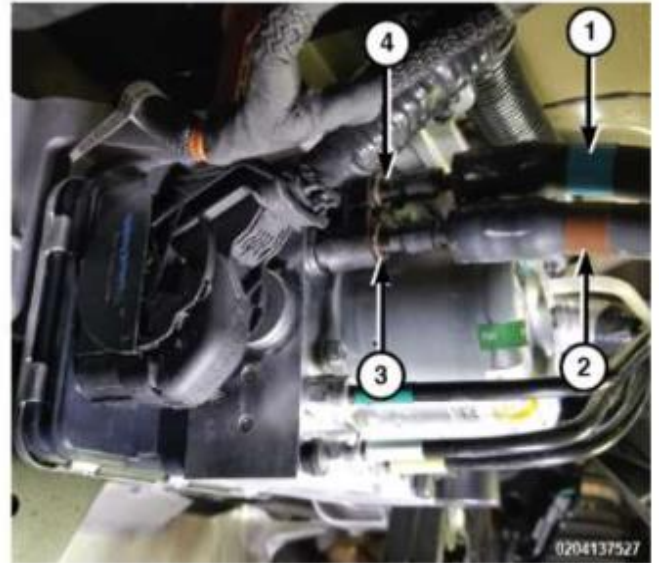
Proper removal of the intake and outlet line assemblies

Push in the brown retainer ring (3) on the air compressor and disconnect the outlet hose (2).

Push in the brown retainer ring (4) on the air compressor and disconnect the inlet hose (1).
