STAR ONLINE PUBLICATION

Case Number: S2208000154

Release Date: September 2022

Symptom/Vehicle Issue: Service Hybrid Electric Vehicle System Message Displayed In The IPC. Vehicle Shakes During A Cold Start And Noise Is Heard Near The P2 Motor. DTC's U0287-00 And B273C-00

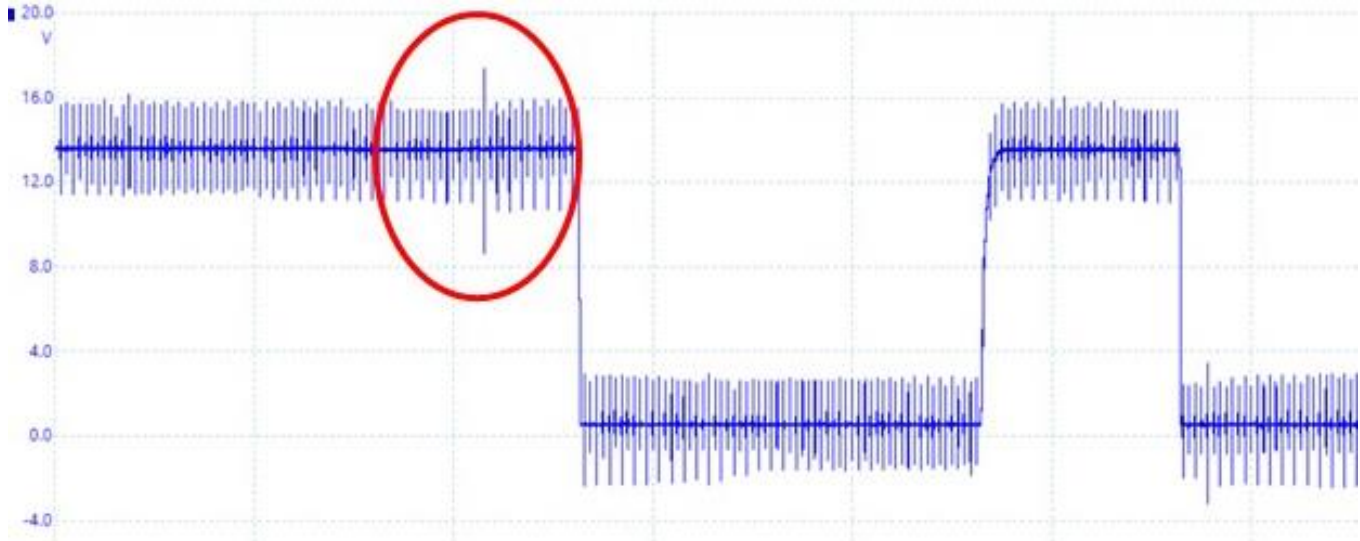
Circuit R414. Electrical noise and voltage spikes caused by HV induction

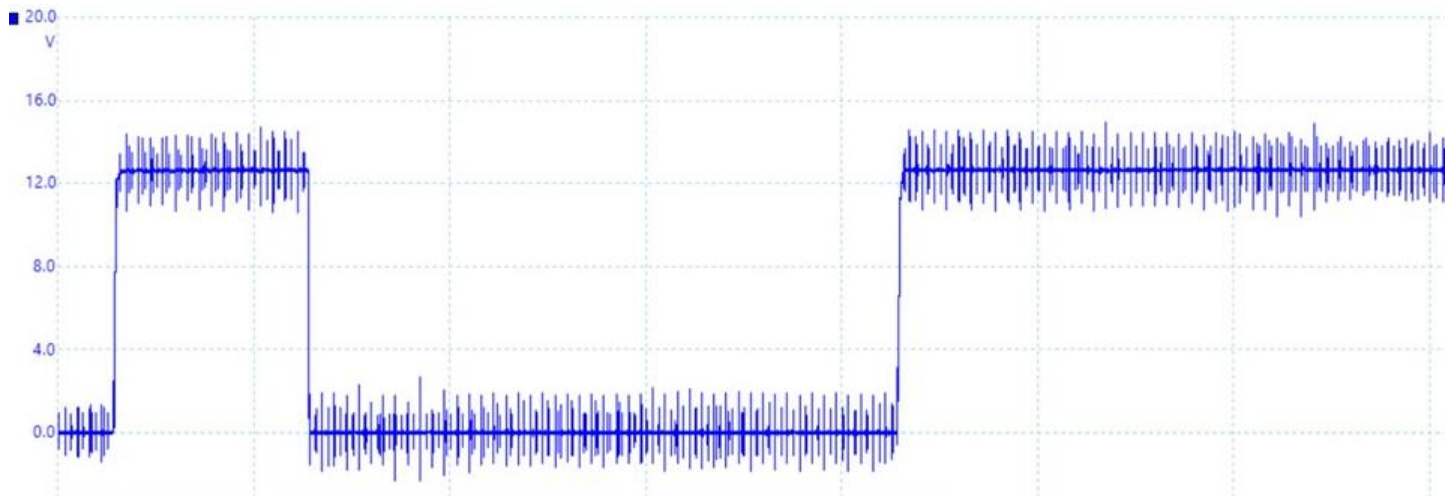
Circuit R414. Known Good Vehicle. Normal scope pattern.
