Case Number: S2225000004

Release Date: September 2022

Symptom/Vehicle Issue: Customer complaint may include MIL-On/check engine lamp-on condition. Upon further inspection, a DTC for P0456-Small Leak Detected may be set in the PCM.

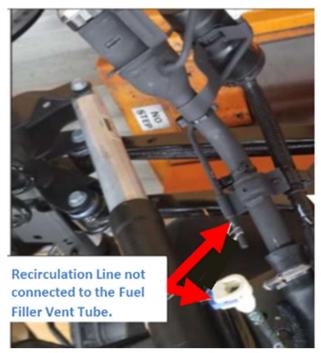
Figure 1

Discussion: If leakage is detected after performing Wi-Tech EVAP Small Leak Verification Test (SLVT), then check for proper connection of the recirculation line at the fuel filler vent tube as shown in figure 1.

Unless the connection is obviously not connected (as in figure 1), perform a pull-pushpull test on the connection.

If the quick connect is found to be loose, then properly connect the line to the fuel filler vent tube and run Wi-Tech EVAP Small Leak Verification Test (SLVT) again to confirm that the leakage is no longer present.
