STAR ONLINE PUBLICATION

Case Number: S2208000158

Symptom/Vehicle Issue: Service Lane Departure Warning Message

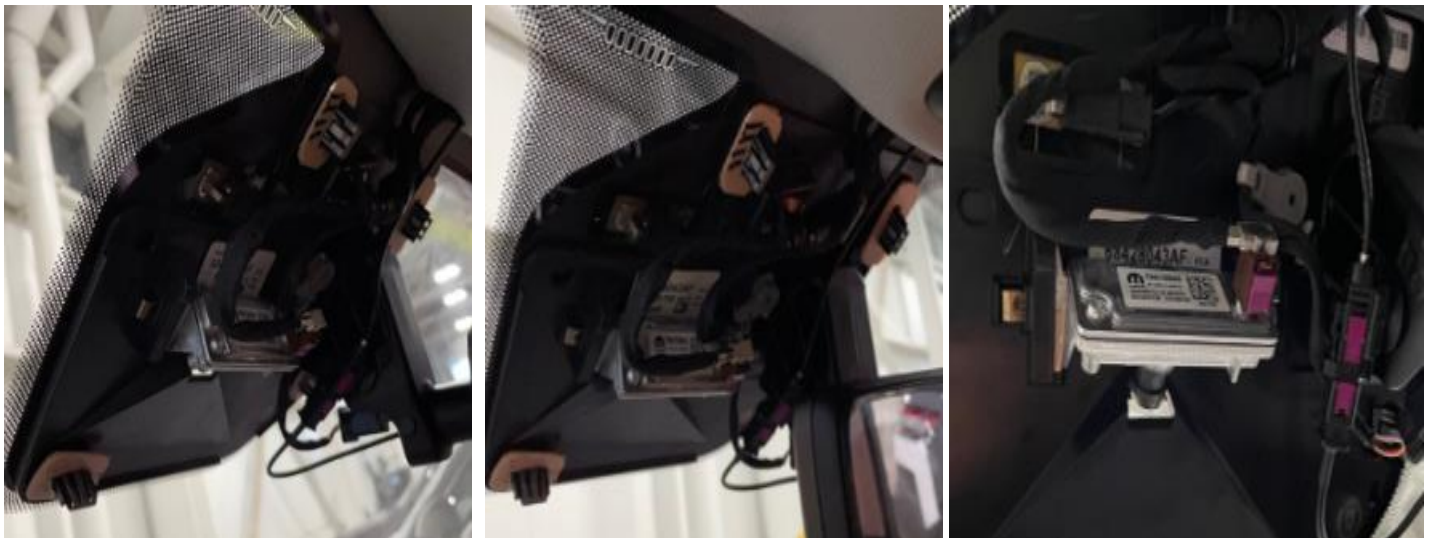
Customer Complaint/Technician Observation: Owner complains of a cluster message to service the lane departure system that appears after a recent windshield replacement and or service repair. Technician observed one or more of the following Diagnostic Trouble Codes DTC's C2318-54 Front Camera Missing Calibration, C2318-76 Incorrect Camera Mounting, C00C1-86 Front Radar Module "B" Invalid, C001C-87 Front Radar Module "B" Missing Message.

Repair Procedure: Inspect the front camera to bracket attachment locators to ensure they are fully engaged and secure; see below images. Inspect the camera connector for any bent or pushed out terminals and secure the connector using the push-pull-push method.

In some cases, a service flash may create the above cluster message. In these cases, perform a RESET of the Central ADAS Decision Module (CADM) using the scan tool – Guided Diagnostics >ECU Reset> Select ECU> CADM. Perform a full key off BUS sleep cycle, following the diagnostics in Service Library to complete the calibration before replacing a camera.
