Case Number: S2214000002

**Symptom/Vehicle Issue**: Customer complaint of fuel filler tube loose or rattling at nozzle fill location.

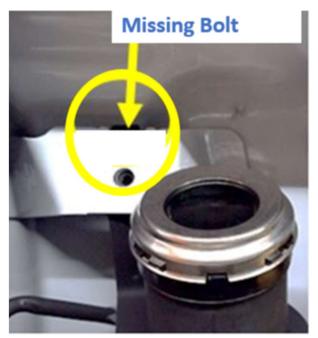
**Repair Procedure**: If the fuel filler tube is found to be loose then inspect the fuel filler bracket area for the attachment bolt.

- If the bolt is loose then tighten the bolt to 8 Nm +/- 0.8 Nm.
- If the bolt is missing (Fig 1), then install the bolt (p/n 06104366AA or its equivalent) and torque the bolt to 8 Nm +/- 0.8 Nm.
