STAR ONLINE PUBLICATION

Case Number: S2208000165

Release Date: September 2022

Symptom/Vehicle Issue: No Start, No Crank, Interior Lamps Flicker, Interior Camera

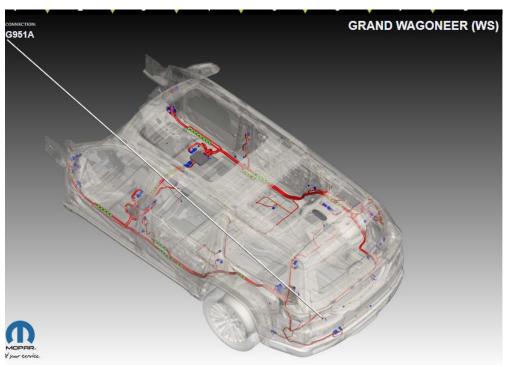
Owner Complaint/Technician Observation: Owner complains that the vehicles interior lamps flicker, the vehicle may not start at times or the interior camera if equipped has no display. Technician observed the vehicle was not setting any Diagnostic Trouble Codes (DTC's), and the Radio Frequency Hub (RFHUB) goes offline intermittently.

Repair Procedure: Inspect ground location G951A, clean and secure the ground as needed. No parts required Fig 1 and 2.
