STAR ONLINE PUBLICATION

Case Number: S228A000003 – REV. A

Release Date: September 2022

Symptom/Vehicle Issue: Uconnect Box Error Message On Radio Screen And Diagnostic Trouble Code (DTC) code B22A9-96 Set

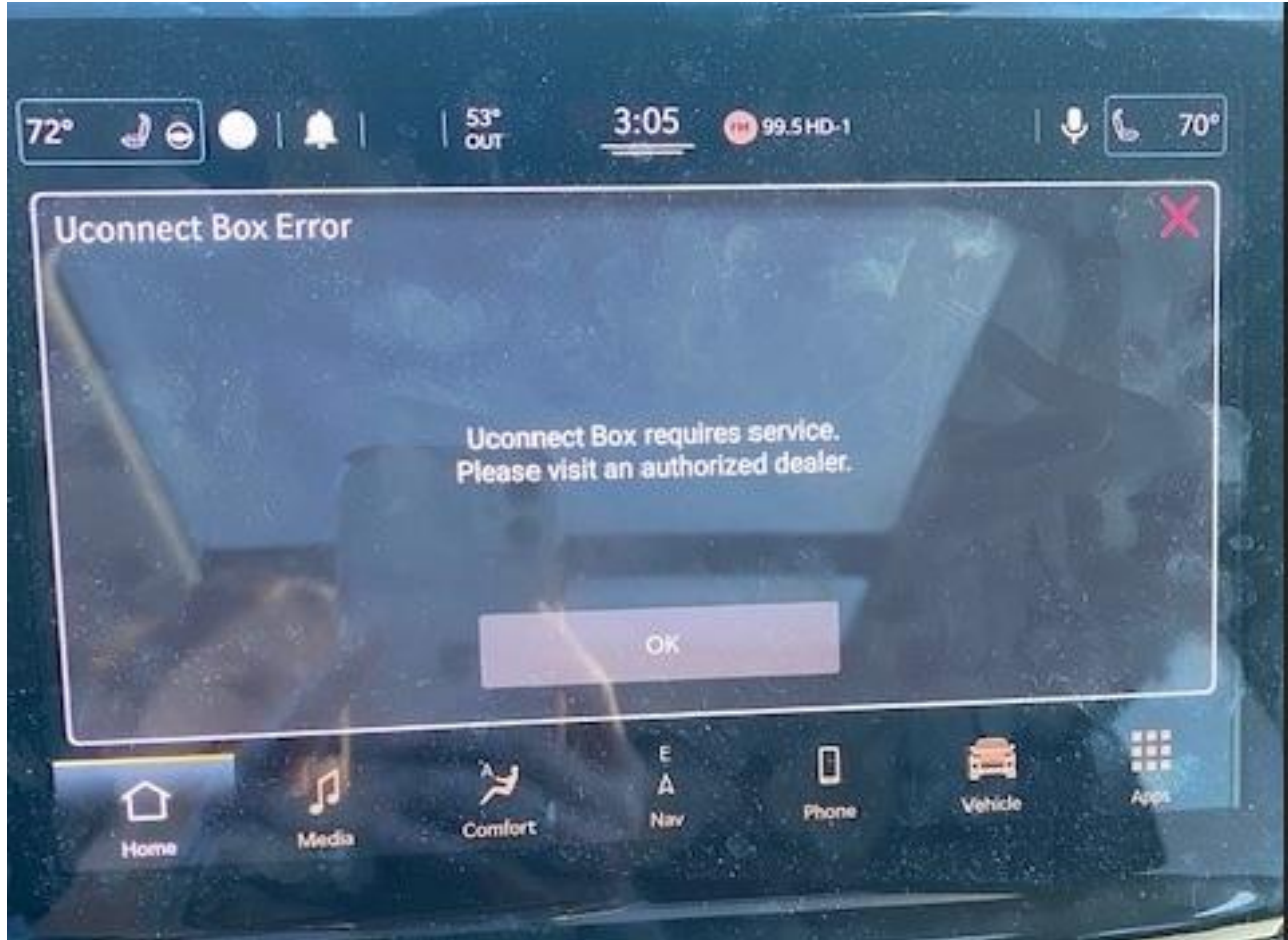
Fig 1 Error Message

Discussion: The customer may report “Uconnect Box requires service” error popup on radio screen every time the vehicle starts. wiTECH shows active DTC B22A9-96 (ECU internal performance) set by Telematics Box Module 2, (TBM2).

1. Check the TBM2 software version and update the TBM2 if service software is available.
2. Verify if Uconnect box error message disappeared and DTC went stored.

3. If the issue continues, pull out the TBM2 module fuse.
4. Disconnect all TBM2 harness connectors.
5. Disconnect all related in-line harness connections (if equipped).

6. Disconnect the related component harness connectors.
7. Inspect harness connectors, component connectors, and all male and female terminals for connector improper installation, connector lock damage, corrosion, water intrusion, bent terminals, overheating or terminal discolored, terminals pushed out.
Perform a terminal drag test on each connector terminal to verify proper terminal tension.

8. Repair any conditions that are found.
9. Reconnect all TBM2 harness connectors and in-line harness connectors and related component harness connectors. Be certain that all harness connectors are fully seated, and the connector locks are fully engaged.

10. Plug in the TBM fuse.
11. Perform Proxi and TBM2 hard reset.
12. Erase the DTCs and perform wiTech scan again.
13. Replace the TBM2 module, if B22A9-96 DTC is still active.
