## STAR ONLINE PUBLICATION

**Case Number:** S2208000166

**Symptom/Vehicle Issue:** No Start, Flashing Odometer, Power Windows Do Not Respond, Power Liftgate and Memory Seat Controls Inoperative, Rear Cabin HVAC Controls Inoperative

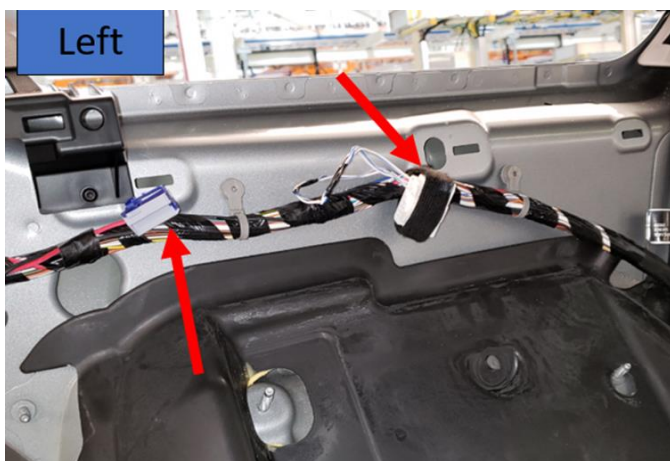
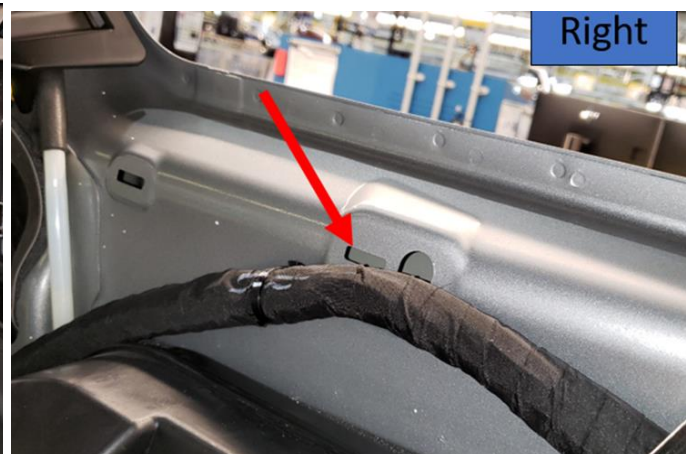
**Owner Complaint/Technician Observation:** Owner complains of the above electrical concerns. Technician observed the vehicle may have set multiple Interior High Speed (IHS) bus faults. Some of the associated Diagnostic Trouble Codes (DTCs).

**Repair Procedure:** Inspect the harness routing behind the left and right rear quarter trim panels to ensure the harness is not pinched in the areas shown. Repair the harness, reposition, and secure as needed.
