Revision (3) September 2022

Dealer Service Instructions for:

Emissions Recall U90 Catalyst Efficiency

About 368,504 of the above vehicles may exceed tailpipe emission standards due to a loss of catalyst CO/NOx conversion efficiency resulting from the catalyst operating at high temperatures.

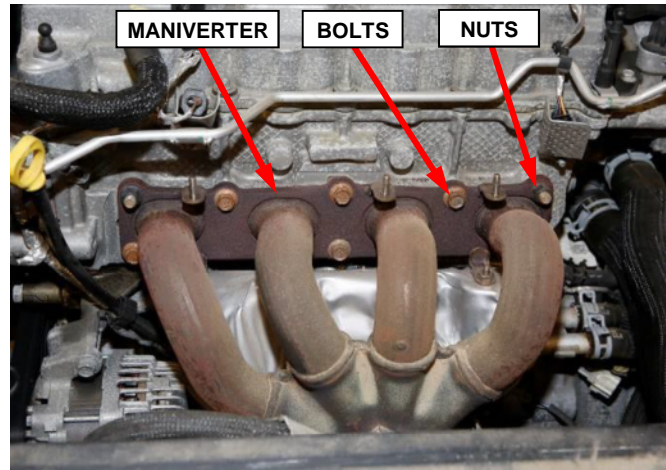
Figure 17 – Maniverter to Engine

CAUTION: Use care when removing the bolts that secure the maniverter to the engine cylinder head. Aluminum cylinder head fastener threads are susceptible to damage if the bolts are not removed with care. Use hand tools **ONLY**.

25. Remove the fasteners, six bolts and two nuts, securing the maniverter to the engine cylinder head (Figure 17).

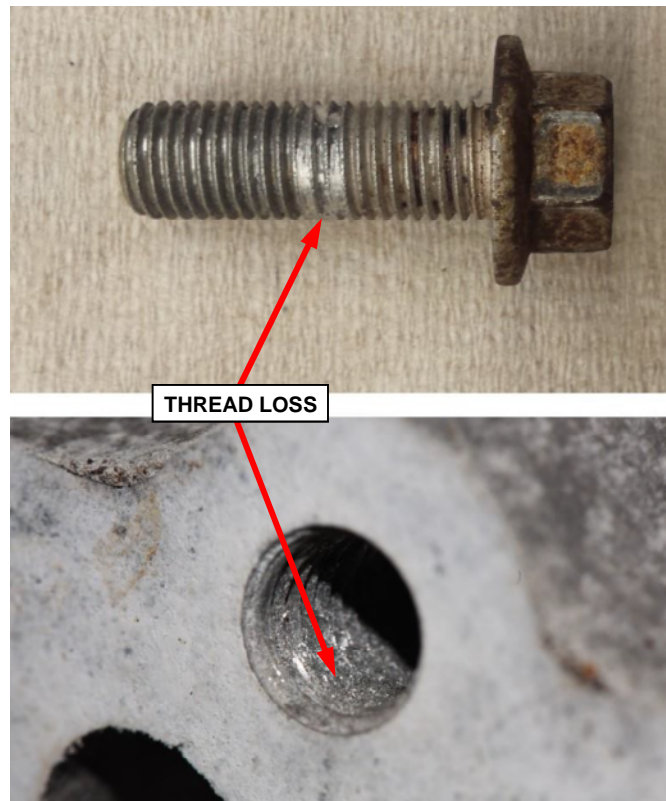
Figure 18 – Inspect for Thread Loss

NOTE: Pay attention to the bolts for signs of thread loss or bolt breakage as they are removed and note which hole they came from (Figure 18).

26. Inspect the bolts and bolt holes for any signs of thread loss then **DISCARD** the bolts (Figure 18).
- If bolt holes do not show signs of thread loss, proceed to **Step 29**.
 - If bolt holes show signs of thread loss, continue with **Step 27**.
 - If a bolt is broken off in the hole, proceed to **Step 28**.

27. If thread loss is suspected, use compressed air to remove any debris from the suspect bolt hole. With the old maniverter and gasket still in place on the engine head, install a **NEW** exhaust manifold bolt in the suspect hole and tighten the bolt to 34 N·m (25 ft. lbs.) to determine if proper torque can be achieved.

- If the bolt is able to be tightened to 34 N·m (25 ft. lbs.), no further action is required. Remove the bolt and proceed to **Step 29**.
 - If the bolt hole threads are stripped allowing the bolt to rotate, unable to achieve proper torque, remove the bolt and continue with **Step 28**.

28. For stripped hole(s) or broken bolt(s), submit a collateral damage claim to obtain authorization for installing a helicoil in the damaged hole(s). Remove the maniverter and gasket following **Steps 29 - 31**. Then use the special tool **2073500090 - Kit, Cylinder Head Thread Repair - 2.4L MAIR** to perform the helicoil thread repair operation by following the service instructions published in **DealerCONNECT / Service Library / Engine, 2.4L Multiair / Standard Procedure / Exhaust Manifold Fastener Hole Repair**. After the damaged bolt hole(s) have been repaired with helicoil(s), proceed with **Step 32**.
