This bulletin supersedes Technical Service Bulletin (TSB) 08-068-22, date of issue March 26, 2022, which should be removed from your files. All revisions are highlighted with **asterisks**** and include an updated build date.**

Global Telematics Box Module (TBM2) Firmware Over The Air Software Version Updates

2022 (MP) Jeep Compass

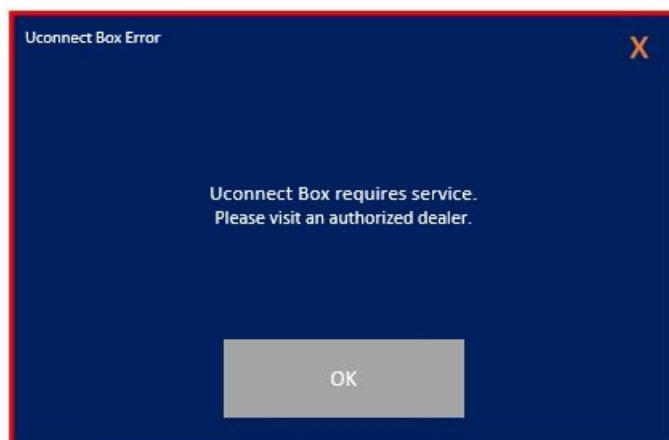
Fig. 1
Error Message

- Message displayed on the radio screen, "Uconnect Box requires service. Please visit an authorized dealer." (Fig. 1) .

- B1570-93 - USB Communication-No Operation.

Vehicles sold in the U.S. and Canada can now receive software updates “over-the-air”. Updates to software will occur in a phased roll-out. The software is updated through a built-in cellular modem in the vehicle. Customers will see a notification on their radio screen when new software is available for their radio (Fig. 2) . The owner will have the option to update the radio or schedule the update for later. There is not an option to decline the update indefinitely, the update must be performed.
