NUMBER: 08-174-22

Uconnect Theater USB Port Inoperable

This bulletin involves connecting inline connector XY314B.

2022 (RU) Chrysler Pacifica

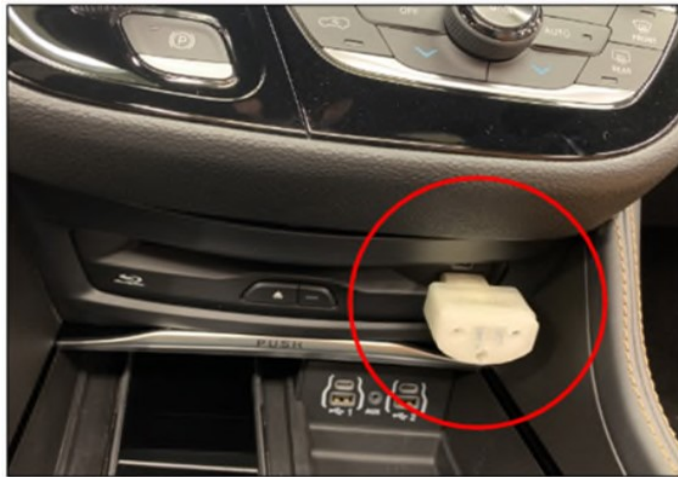
Fig. 1
USB Port On The DVD/Blu-Ray Player

- The USB port on the DVD/Blu-Ray player (Uconnect Theater) is inoperable.

1. Plug in a media device and test the USB port on the DVD/Blu-Ray player (Uconnect Theater) (Fig. 1) .

2. Is the USB port on the DVD/Blu-Ray player (Uconnect Theater) inoperative?
 - YES>>> Proceed to [Step 1](#) of the Repair Procedure.
 - NO>>> This bulletin has been completed, use inspect LOP (08-92-PG-91) to close the active RSU.

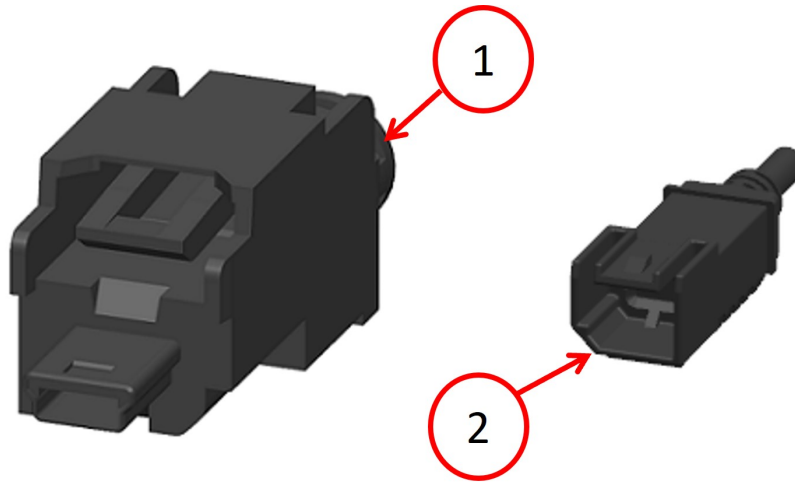
Fig. 3
Connectors

- 1 - Instrument Panel Black Wiring Harness Connector
- 2 - XY314B Single Wire Body Wiring Harness Connector

1. Remove the cowl trim panel. Refer to the detailed service procedures available in DealerCONNECT> Service Library under: Service Info>23 - Body / Interior / Panel, Cowl Trim / Removal.
2. Connect the instrument panel black wiring harness connector (Fig. 2) , to the XY314B single wire body wiring harness connector (Fig. 3) .
