NUMBER: 23-037-22

Steering Wheel Leather Peeling at Lower Ring

2022 (WL) Jeep Grand Cherokee

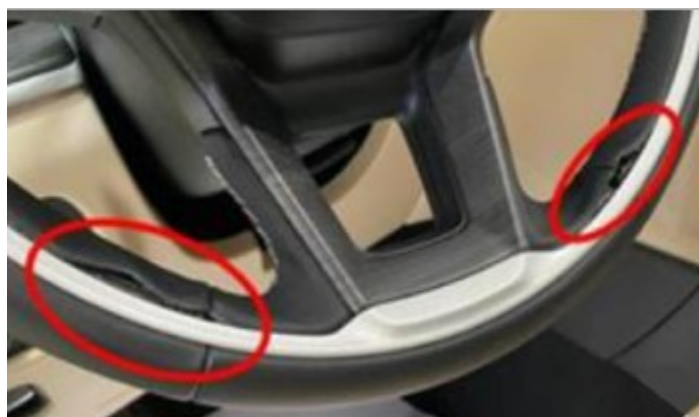
- Steering wheel leather wrap loose or peeling due to lack of glue around the three to five and/or the seven to nine o'clock positions. (Fig. 1) .

Fig. 1
Leather Wrap Peeling

1. Replace the steering wheel and hex lock nut. Refer to the detailed service procedures available in DealerCONNECT/Service Library under: Service Info> 19 - Steering /Column /Wheel, Steering /Removal and Installation.

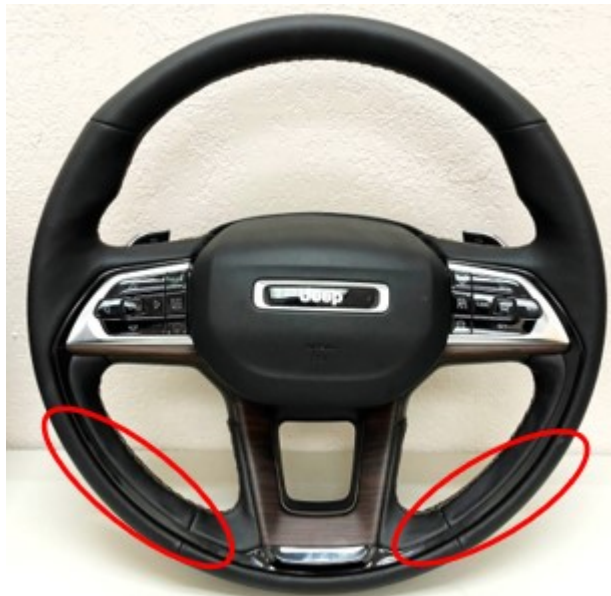
1. Inspect the steering wheel leather wrap around the three to five and/or the seven to nine o'clock positions.
2. Look for any evidence of exposed leather edges along the decorative ring area (Fig. 2) .

Fig. 2
Decorative Ring Area

3. Run your thumb along the ring twisting from the outside of the wheel to see if the leather is loose next to the ring (Fig. 2) .

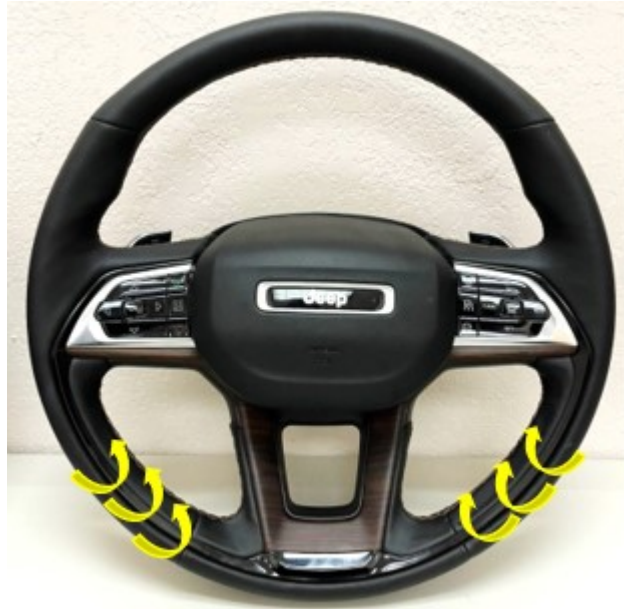
4. Twist the leather wrap in the direction shown by the yellow arrows in (Fig. 3) .

Fig. 3
Twisting Direction

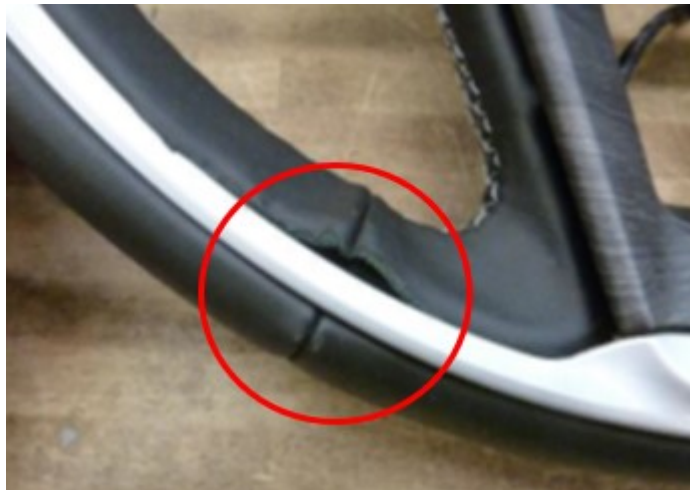
5. Is the leather loose, or peeling around the three to five and/or the seven to nine o'clock positions (Fig. 4) and (Fig. 5) ?

Fig. 4
Leather Peeling

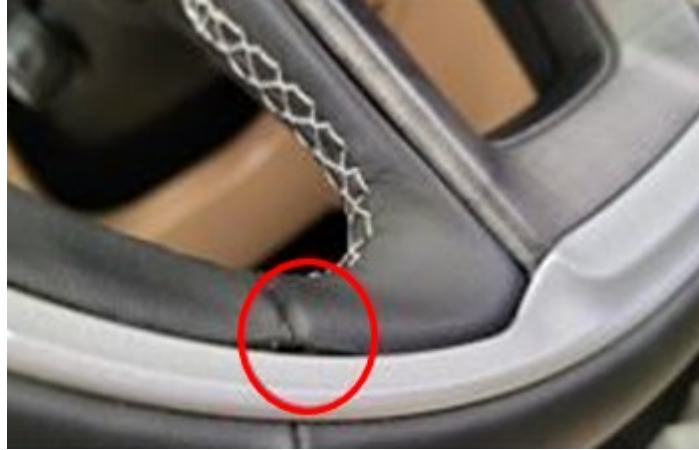
Fig. 5
Leather Peeling
