NUMBER: 23-038-22

Overhead Console To Headliner Gap

This bulletin involves eliminating the gap between the overhead console and headliner.

2022 (WS) Grand Wagoneer/Wagoneer

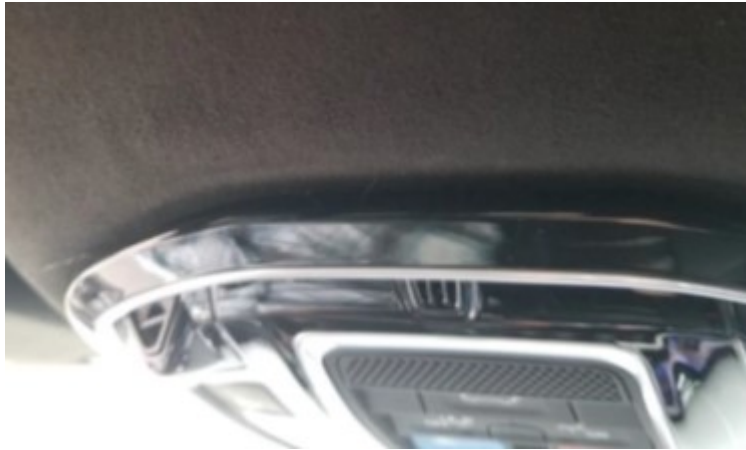
- A rattle noise from the overhead console.
- Observe a gap at the headliner and overhead console.

1. Is there a gap between the overhead console and headliner (Fig. 1) ?

Fig. 1
Overhead Console Gap

- YES>>> Proceed to [Step 1](#) of the Repair Procedure.
- NO>>>This bulletin is complete. Use Inspection LOP (23-14-02-95) to close this RSU.

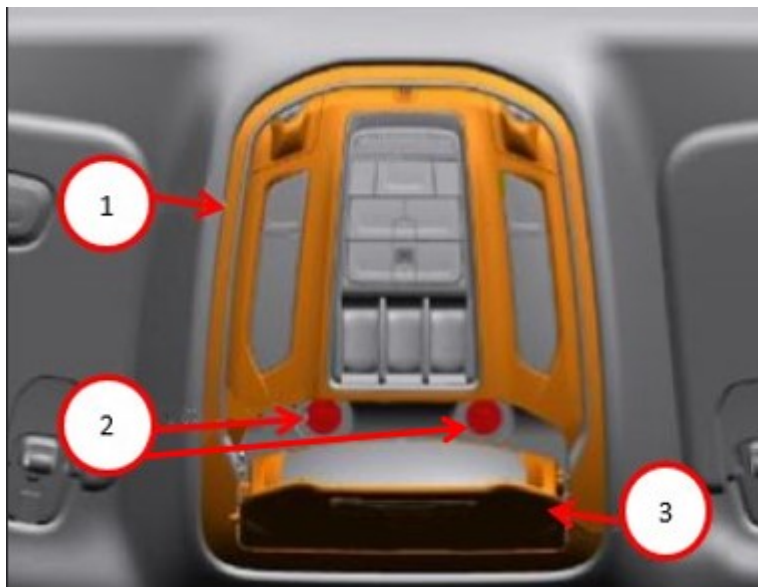
Fig. 2
Overhead Console

- 1 - Overhead Console
 - 2 - Fasteners
 - 3 - Sunglass Compartment
-

1. Open the sunglass compartment and remove the two overhead console fasteners (Fig. 2) .

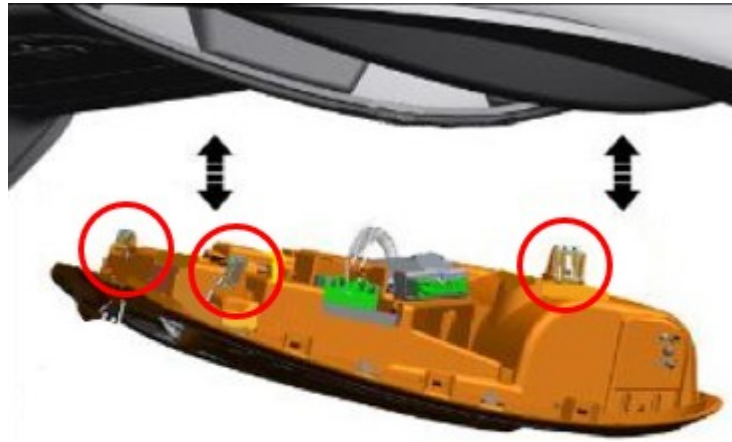
Fig. 3
Overhead Console Retainers

- 2. Use a trim stick at the locations of the 3 metal clips to release the console from the roof structure (Fig. 3) .

- 3. Inspect the metal retaining clips. Address any bent or damaged clips as needed.
- 4. Snapping the metal clips in first, install the overhead console, then install the two retaining fasteners.
