**NUMBER:** 08-175-22 REV. A

Water Intrusion and Corrosion in Connector XY101A

2022 (RU) Chrysler Pacifica

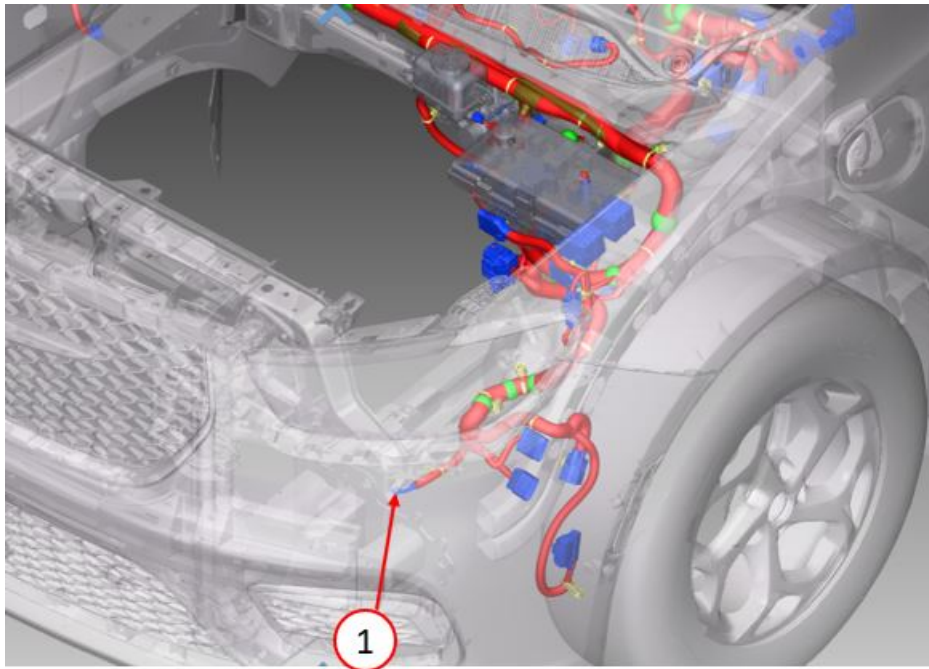
**Fig. 1**  
**Ground Location**

1 - G917A Location

1. Remove air intake system. Refer to the detailed service procedures available in DealerCONNECT> Service Library under: 09 - Engine, 3.6L / Air Intake System / Body, Air Cleaner / Removal.
2. Is the vehicle a PHEV?
  - YES>>> Proceed to [Step 4](#).
  - NO>>> Proceed to [Step 3](#).
3. Remove the battery and battery tray. Refer to the detailed service procedures available in DealerCONNECT> Service Library under: 08 - Electrical / 8F - Engine Systems / Battery System / Tray, Battery / Removal.
4. Locate G917A and disconnect the ground from the chassis and the gray harness retainer ([Fig. 1](#)).
