# TECHNICAL SERVICE BULLETIN

Classification: AT22-014	Reference: NTB22-093	Date: October 27, 2022
-----------------------------	-------------------------	---------------------------

## DTC P0780 STORED IN THE TCM

**APPLIED VEHICLES:** 2021 Rogue (T33)  
**APPLIED ENGINES:** PR25DD

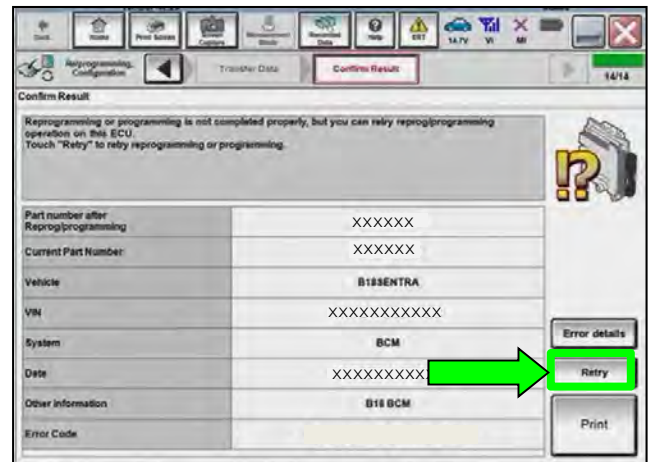
Figure 16

If reprogramming does not complete and the “!” symbol displays as shown in Figure 16:

- Check battery voltage (12.0 – 15.5V).
- Ignition is ON, Engine is OFF.
- External Bluetooth® devices are OFF.
- All electrical loads are OFF.
- Select **Retry** and follow the on screen instructions.

**HINT:** **Retry** may not go through on first attempt and can be selected more than once.

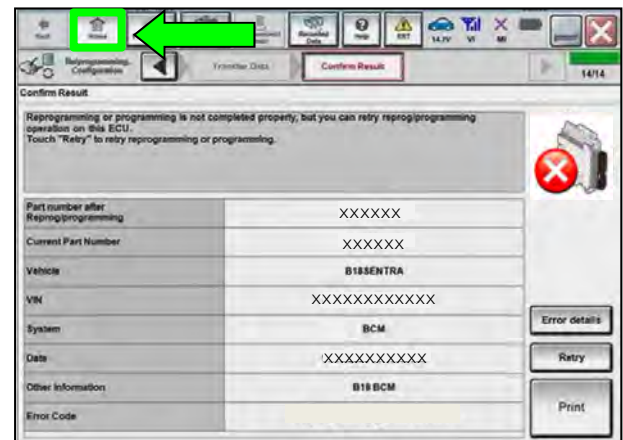
Figure 17

If reprogramming does not complete and the “X” symbol displays as shown in Figure 17:

- Do not disconnect the VI or shut down C-III plus if reprogramming does not complete.
- Check battery voltage (12.0 – 15.5V).
- CONSULT A/C adapter is plugged in.
- Ignition is ON, Engine is OFF.
- Transmission in Park.
- All C-III plus / VI cables are securely connected.
- All C-III plus updates are installed.
- Select **Home**, and then restart the reprogram procedure from the beginning.
