# Service Bulletin

Bulletin No.: 22-NA-221

**Subject: No Start, Slow Crank or Low 12V Battery**

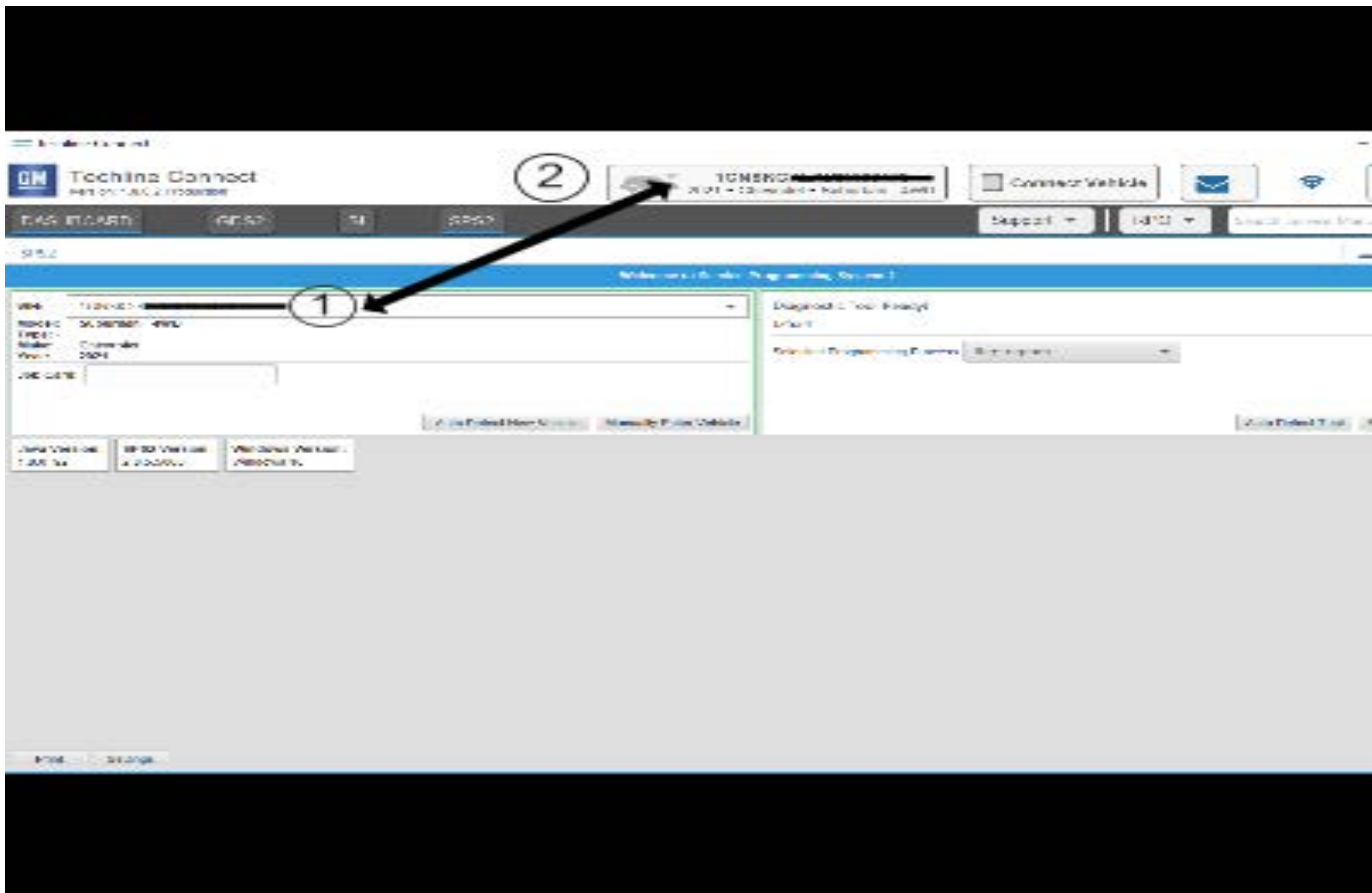
**Caution:** Be sure the VIN selected in the drop down menu (1) is the same as the vehicle connected (2) before beginning programming.
