Service Bulletin

Bulletin No.: 22-NA-224

Subject: Reduced Engine Power, Malfunction Indicator Lamp (MIL) Illuminated - DTC's P0101, P0172, P0299, P0506 and/or P1101 Set

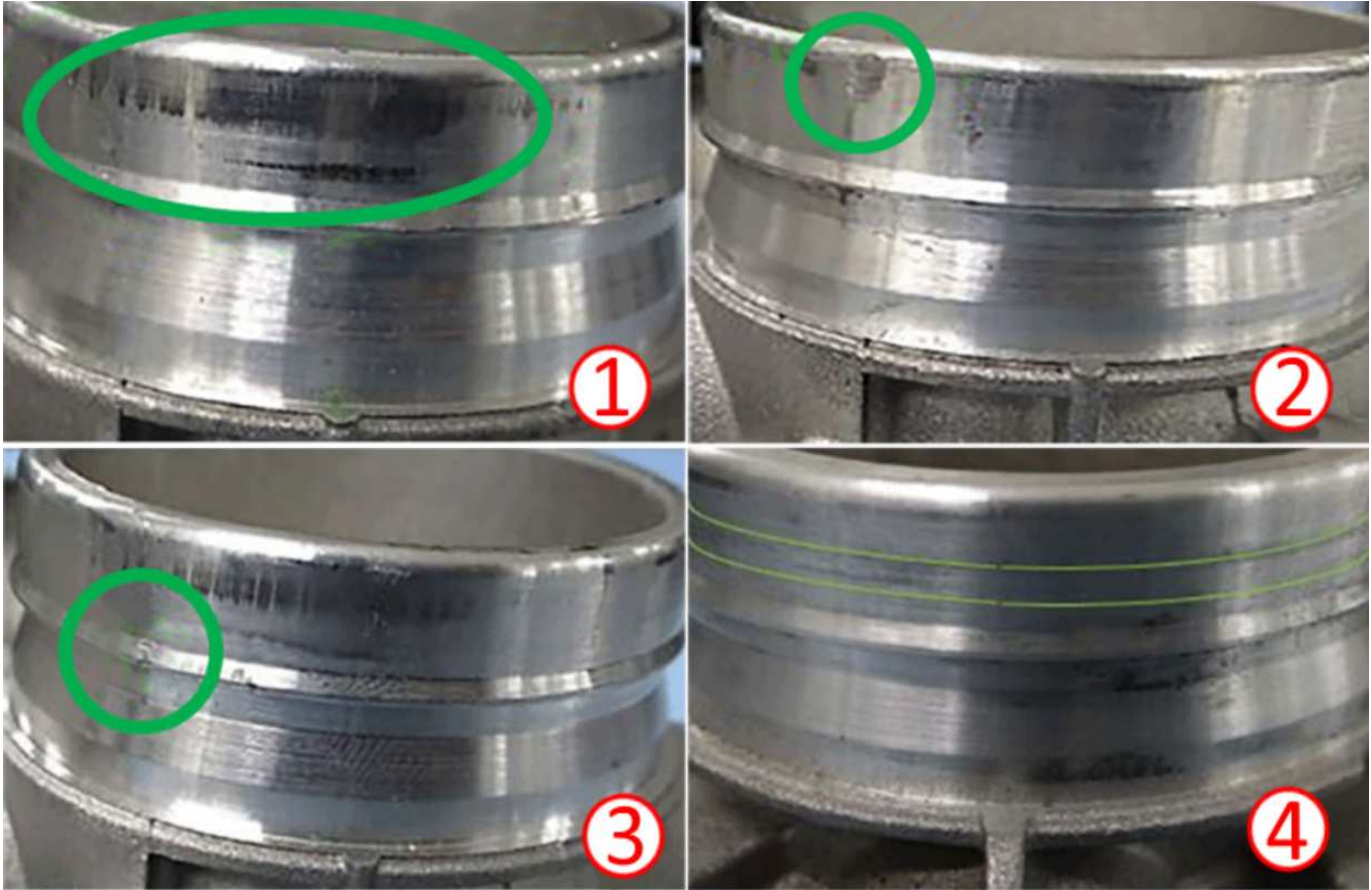
5400480

Graphics 1–4 show normal witness marks on the throttle body and normally will not require replacement.

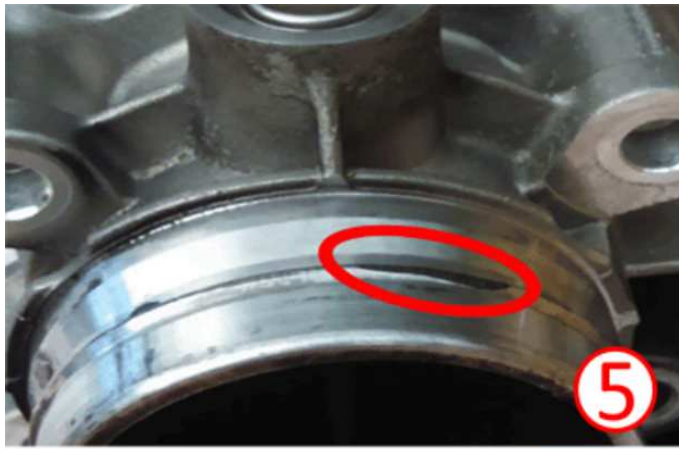
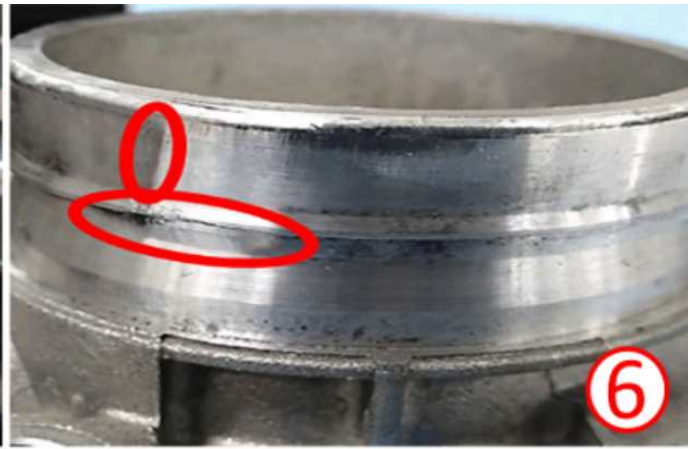
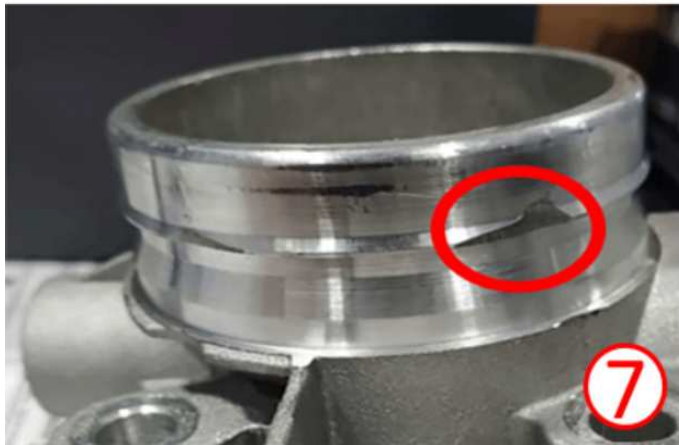
Graphics 5-7 show abnormal witness marks or damage to throttle body and replacement would be required.

When the charge air cooler outlet tube has become disconnected from the throttle body, the tube end should be inspected for contact damage or a missing O-ring seal from blowing off.

If the tube is found to be damaged or the O-ring seal is missing, replace the tube assembly.
