GLOBAL SAFETY FIELD INVESTIGATIONS
DCS6342
URGENT - DISTRIBUTE IMMEDIATELY

Subject: N222379970 - Service Update
Internal Seam and Underbody Sealers Failed Adhesion Testing in
Plant

Models: 2023 Cadillac XT5
2023 Cadillac XT6
2023 GMC Acadia

N222379970 Internal Seam and Underbody Sealers Failed Adhesion Testing in Plant

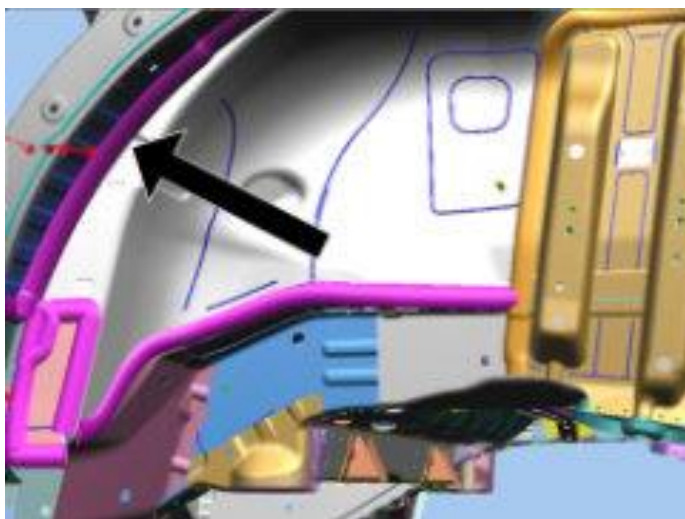
2. Locate the body sealer path indicated in purple in the graphic above.

1. Remove the left rear wheelhouse liner. Refer to *Rear Wheelhouse Liner Replacement* in SI.

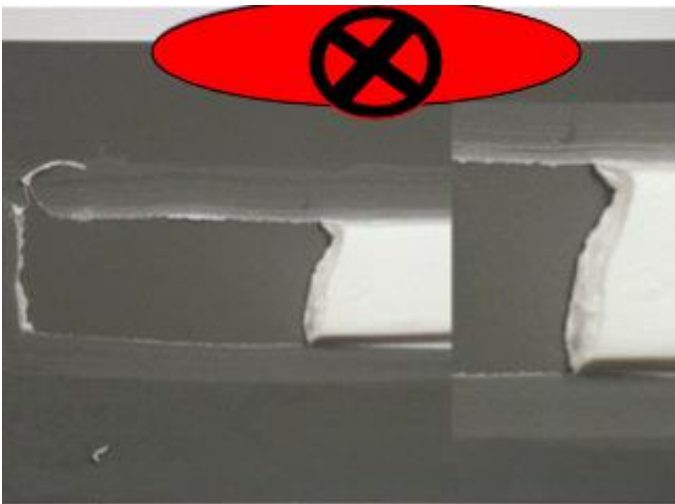
6197153

3. Starting in the lower front corner, use a stiff putty knife or a gasket scraper to attempt to lift the seam sealer from the body.

- If the seam sealer easily peels from the painted (E-Coat) surface, the material is not performing correctly. Proceed to step #4.

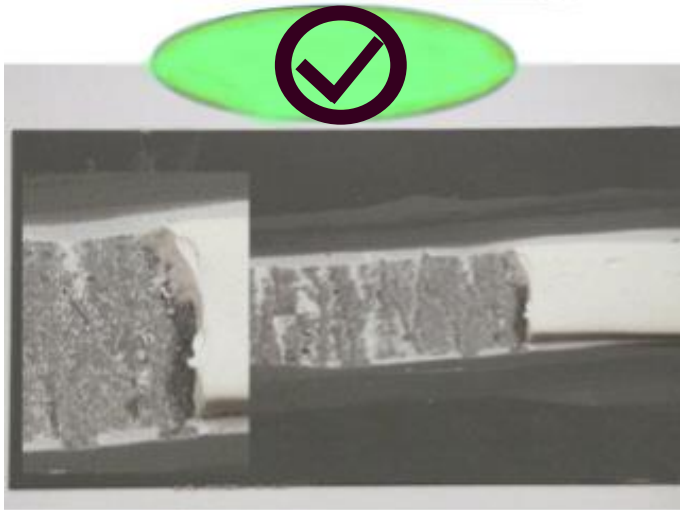
6197151

- If the seam sealer does not peel easily but separates leaving a partial covering of sealer on the painted (E-Coat) surface, no further action is required. Replace any seam sealer that is disrupted during the above step and reinstall the wheelhouse liner. Refer to *Rear Wheelhouse Liner Replacement* in SI.
4. Remove the right rear wheelhouse liner. Refer to *Rear Wheelhouse Liner Replacement* in SI.
 5. Remove the rear bumper fascia. Refer to *Rear Bumper Fascia Removal and Installation* in SI.
 6. Locate the seam sealer application in the following areas, identified in purple. The left side is shown, seal the area on both the left and right sides of the vehicle.

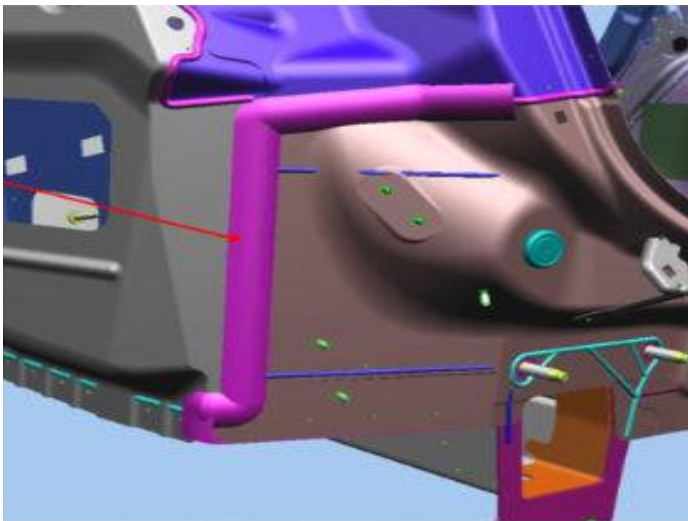
6193061

Left and Right Rear Body Panel

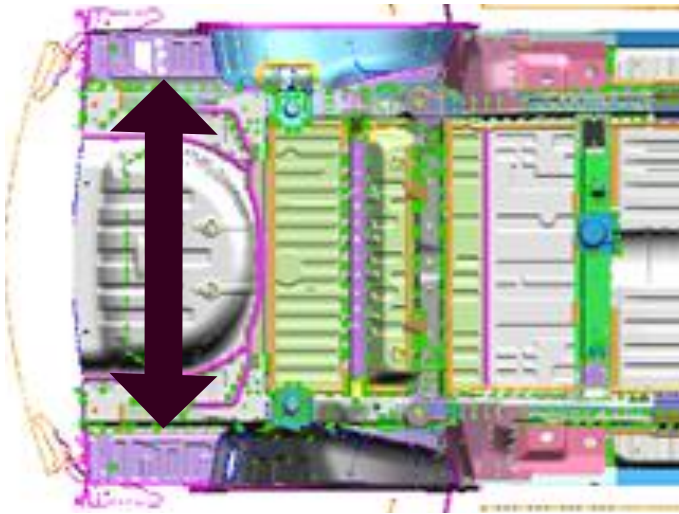
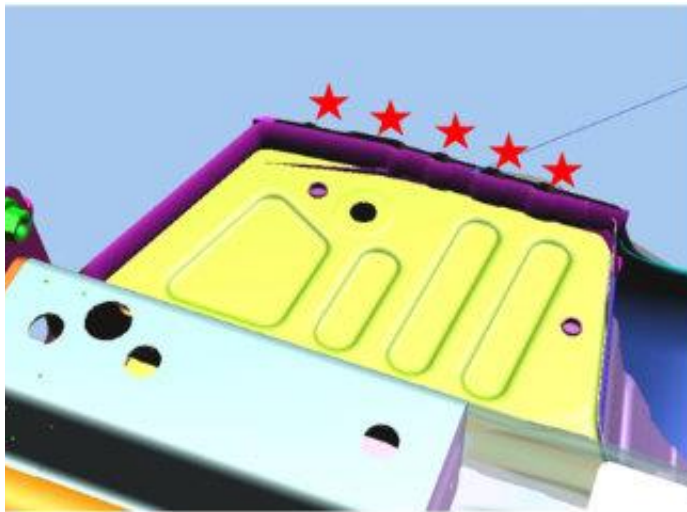
6193064

Left and Right Floor Extensions (Only Service the Flange Noted with Stars)

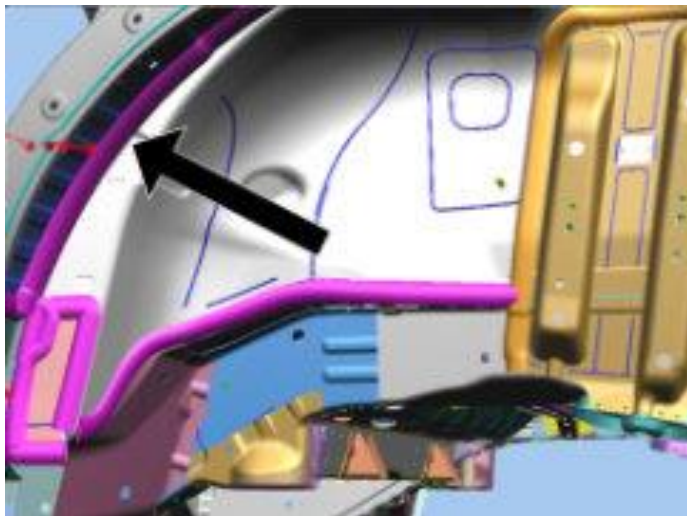
6193049

Left and Right Wheelhouses

7. Using a stiff putty knife or gasket scraper, remove all the seam sealer. Use care to not gouge or damage the painted (E-Coat) surface.
8. Apply the new seam sealer (3-M Bare Metal Seam Sealer # 8310 or equal) per the packaged instructions.
9. If necessary, use a small brush to cover any exposed area of painted (E-Coat) surface. Ensure there is no bare metal exposed.
10. Allow the seam sealer to cure per the packaged instructions.
11. Reinstall the left and right rear wheelhouse liner. Refer to *Rear Wheelhouse Liner Replacement* in SI.
12. Reinstall the rear bumper fascia. Refer to *Rear Bumper Fascia Removal and Installation* in SI.
