Service Update

N222378520 Front Left Corner to Knuckle Fastener Failure

Release Date: November 2022

Models: 2022 Chevrolet Silverado 2500HD/3500HD

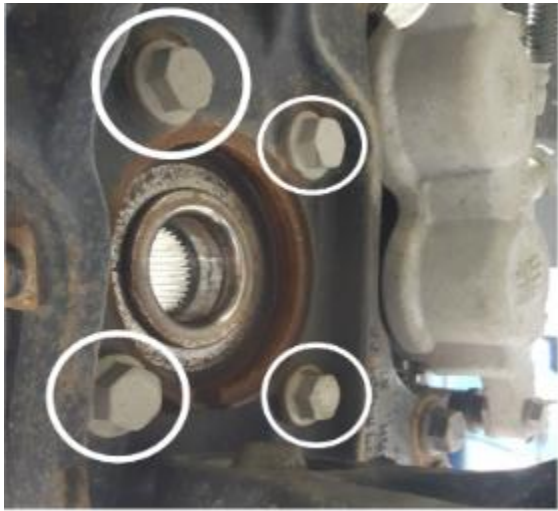
5871509

Note: All four Front Wheel Hub Bolts need to be replaced.

3. One bolt at a time, remove each Front Wheel Hub Bolt and install and tighten a new Front Wheel Hub Bolt to 180 Nm (133 lb ft).
4. (4WD only) Reinstall the left Front Wheel Drive Half Shaft. Refer to *Front Wheel Drive Half Shaft Replacement – Left side* in SI.
5. Lower the vehicle. Refer to *Lifting and Jacking the Vehicle* in SI.
