GLOBAL SAFETY FIELD INVESTIGATIONS
DCS6337
URGENT - DISTRIBUTE IMMEDIATELY

Subject: REVISION: N212354520-02 - Customer Satisfaction Program
Heated Vented Seats Retrofit
Front Seat Heater Vent Module and Programming
Population Update

N212354520 Heated Vented Seats Retrofit - Front Seats Only

Revision: 02

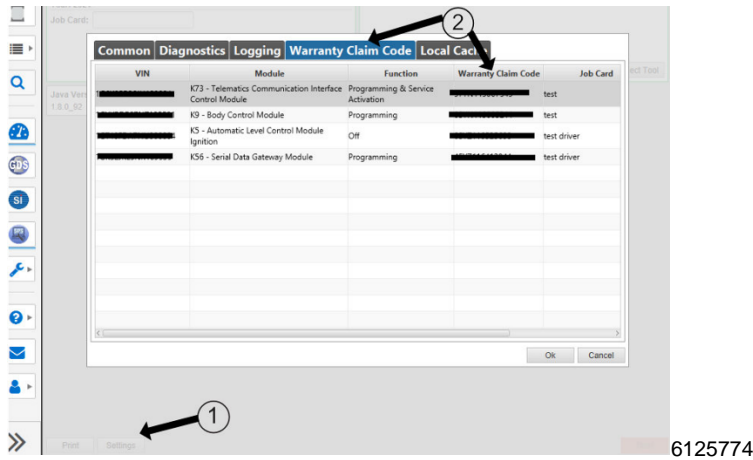
Warranty Claim Code Information Retrieval

If the Warranty Claim Code was not recorded on the Job Card, the code can be retrieved in the SPS2 system as follows:

1. Open TLC on the computer used to program the vehicle.
2. Select and start SPS2.
3. Select Settings (1).
4. Select the Warranty Claim Code tab (2).

The VIN, Warranty Claim Code and Date/Time will be listed on a roster of recent programming events. If the code is retrievable, dealers should resubmit the transaction making sure to include the code in the SPS Warranty Claim Code field.

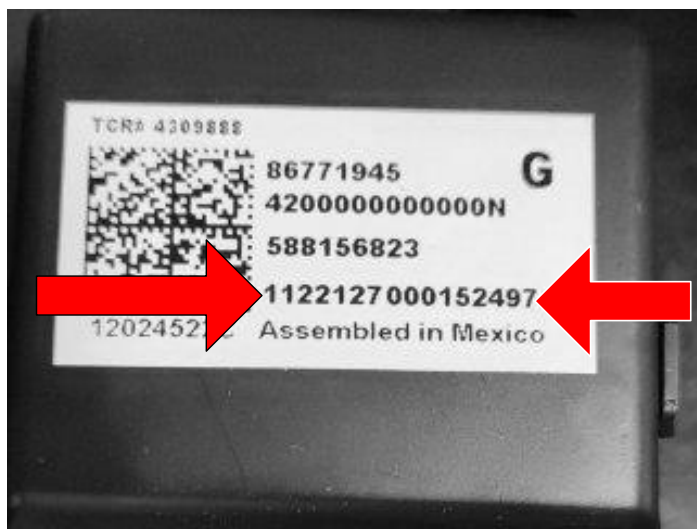
Record the serial number on the front seat heater vent control module labels.

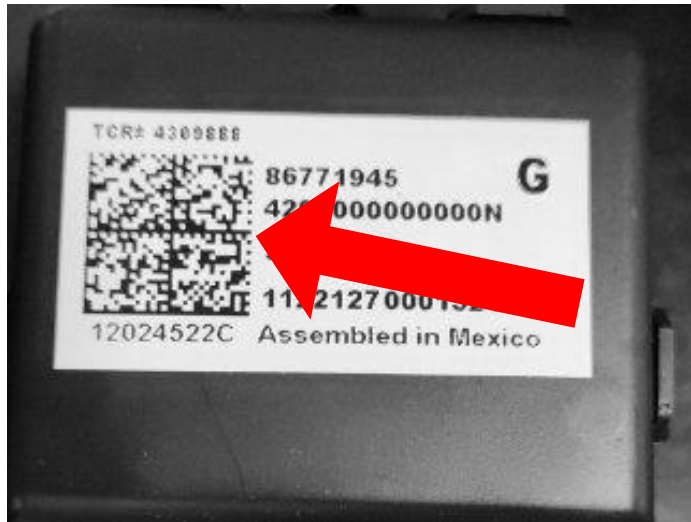
6098077

If the App is already loaded to your phone, simply:

1. Scan the VIN (door pillar QR code or windshield VIN barcode) and
2. Scan the new part (QR code) and
3. Check the information and if correct then, Submit.

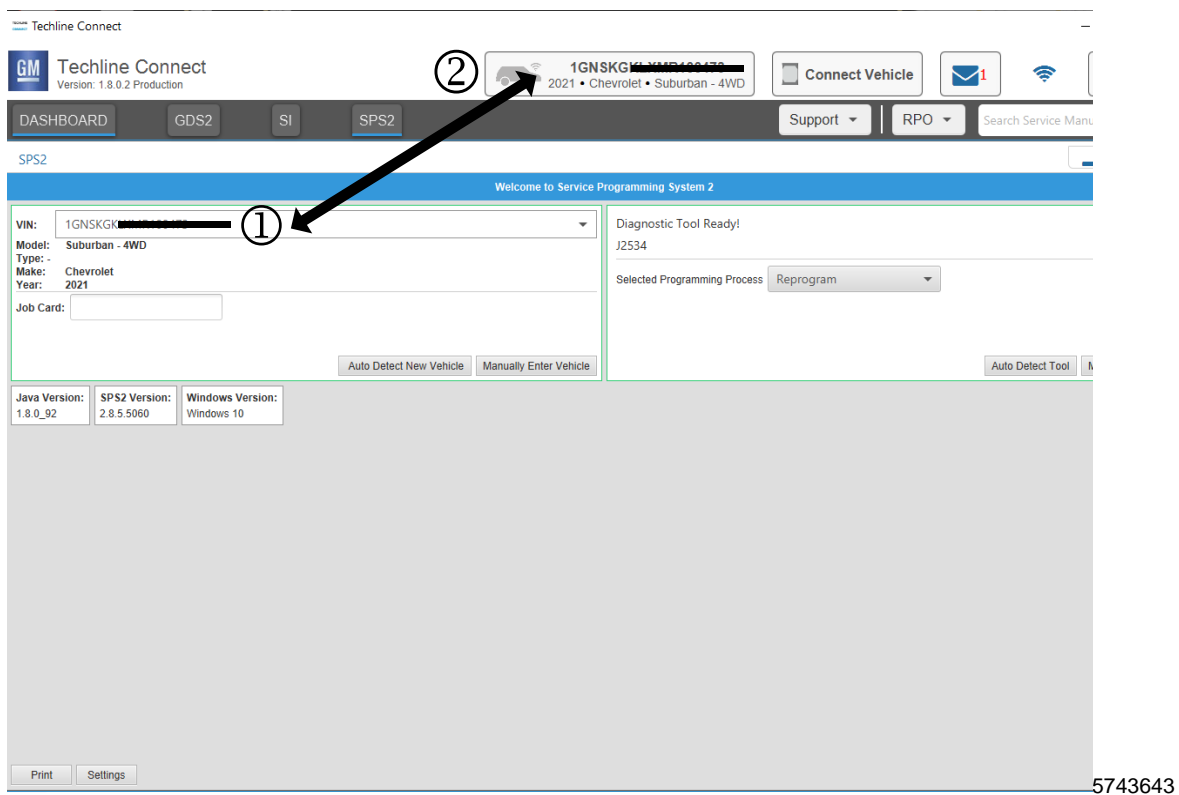
Caution: Be sure the VIN selected in the drop-down menu (1) is the same as the vehicle connected (2) before beginning programming.

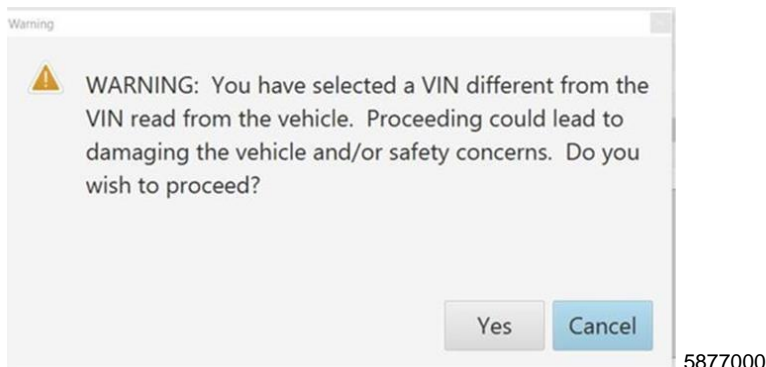
Important: If the vehicle VIN DOES NOT match, the message below will be shown.
