Service Update

N222378521 Front Right Corner to Knuckle Fastener Failure

Release Date: November 2022

Models: 2022 Chevrolet Silverado 2500HD/3500HD

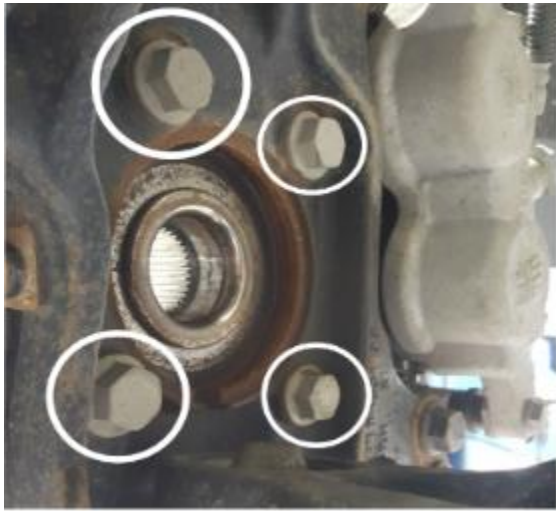
5871509

Condition	On certain 2022 model year Chevrolet 2500HD/3500HD vehicles, the passenger's side front bearing/hub assembly fasteners (bolt that fastens hub to steering knuckle) may have been yielded during assembly.
Correction	Dealers are to replace the front hub bolts on the passenger's side.

Note: All four Front Wheel Hub Bolts need to be replaced.

3. One bolt at a time, remove each Front Wheel Hub Bolt and install and tighten a new Front Wheel Hub Bolt to 180 Nm (133 lb ft).
4. (4WD only) Reinstall the right Front Wheel Drive Half Shaft. Refer to *Front Wheel Drive Half Shaft Replacement – Right side* in SI.
5. Lower the vehicle. Refer to *Lifting and Jacking the Vehicle* in SI.
