Technical Service Bulletin

19 Coolant leak in area of coolant thermostat housing/coolant pump - 2.0TFSI

19 22 33 2061604/5 November 2, 2022. Supersedes Technical Service Bulletin Group 19 number 21-18 dated May 28, 2021, for reasons listed below.

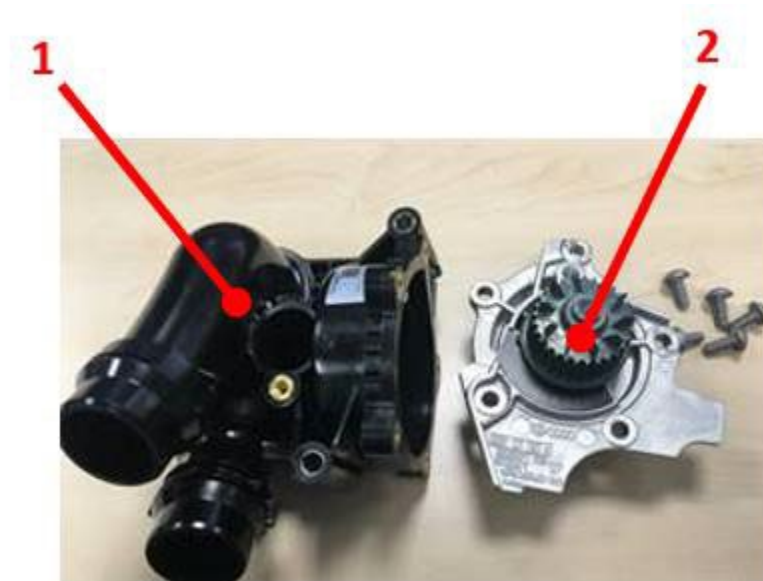
- The leak can be reproduced.
- The cause for the coolant loss is found around the coolant thermostat housing or the coolant pump.

Coolant loss from the coolant thermostat housing (Figure 1, position 1) or the coolant pump (Figure 1, position 2).

Figure 1. Coolant thermostat/coolant pump. Parts are available separately, see the parts table below.

Only replace the leaking component (coolant pump or coolant thermostat housing).

- 1) Remove the coolant thermostat housing including the coolant pump according to Elsa at repair manual:
Engine >> 4 - Cylinder Direct Injection >> 19 Cooling System >> Coolant Pump/Coolant Thermostat >> Coolant Pump, Removing and Installing.
- 2) Separate the water pump and coolant thermostat housing by removing the five connecting bolts (Figures 1 - 2).

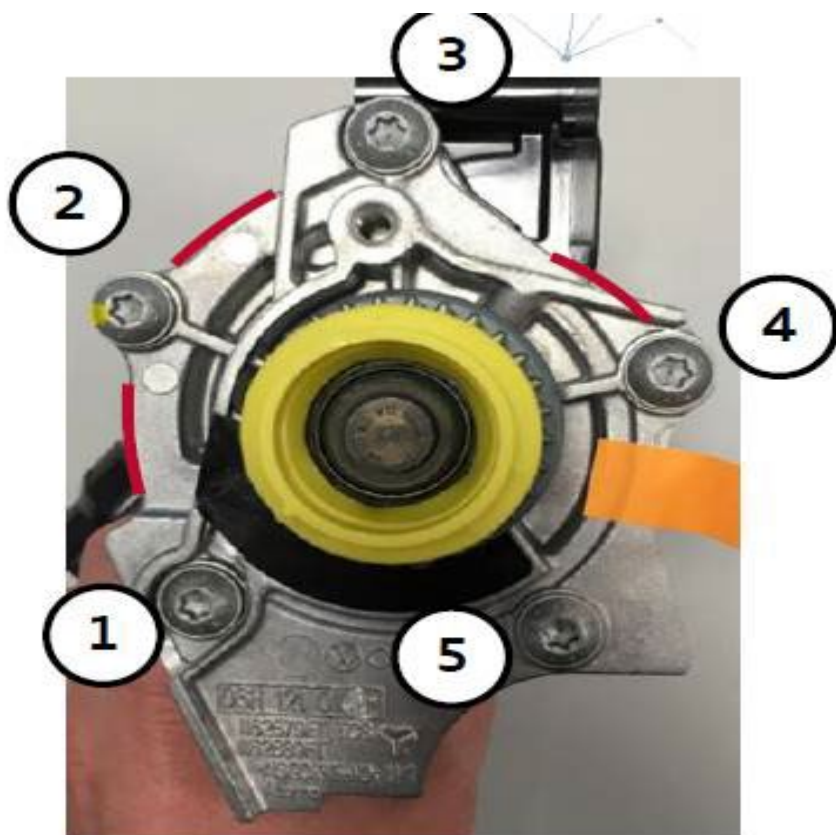
Figure 2. Securing bolts of the coolant pump (1 to 5).

- Assemble the coolant thermostat housing and the coolant pump and attach the five connecting bolts.
- Align the two components against one another in such a way that both components are flush to one another in the areas marked in red (Figure 2). The thermostat housing must not be higher/lower than the coolant pump (run your finger over the three areas to check).
- Torque the connecting bolts of the two components to 10 Nm.

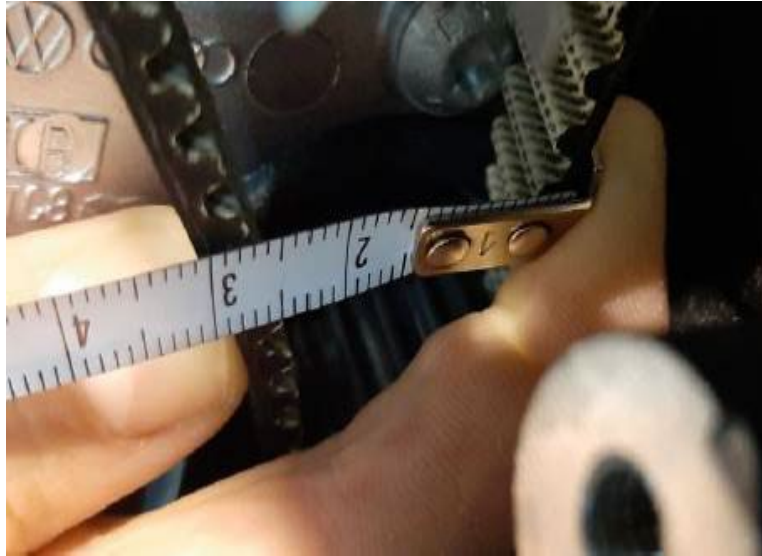
Figure 3. Checking the toothed belt tension.

- 5) Check the toothed belt tension (Figure 3) by pressing the toothed belt together centrally between the two toothed belt sprockets. The measured distance of the backs of the toothed belt should be between 28mm and 30mm. A measuring caliper can also be used for toothed belt compression and measurement.

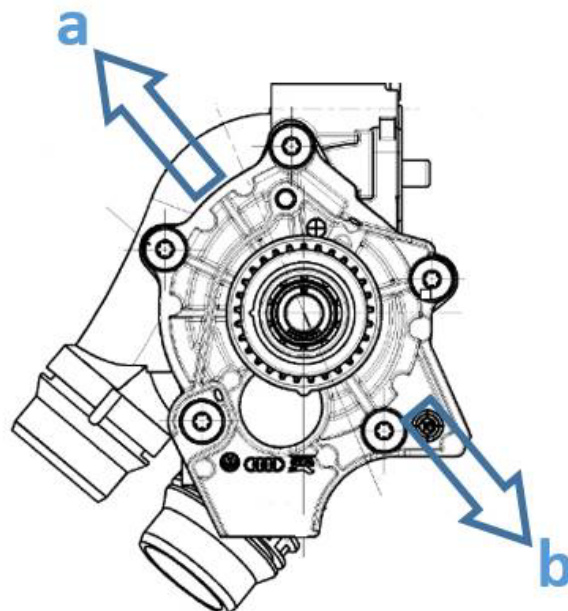
Figure 4. Adjusting the toothed belt tension.

- Make note of the measured value (e.g. 26mm) from step 5.
- Remove the cooling module from the engine again, loosen the coolant pump bolts (Figure 2) and make adjustments as outlined below.
- If the measured distance of the backs of the toothed belt (pressed together) is less than 28mm (e.g. 25mm), then the belt tension is too low. A slight adjustment away from the balance shaft is necessary (**direction "a"**).
- If the distance of the backs of the toothed belt (pressed together) is greater than 28mm (e.g. 32 mm), then the belt tension is too great. A slight adjustment towards the balance shaft is necessary (**direction "b"**).

8) Tighten the five securing bolts of the coolant pump and repeat steps 4 and 5.
