# Technical Service Bulletin

## 34 Function restriction with event memory entry P071800 - P276800 (symptom 20736 - 20737)

34 22 60 2067653/2 November 2, 2022. Supersedes Technical Service Bulletin Group 34 number 22-59 dated July 29, 2022, for reasons listed below.

Model(s)	Year	VIN Range	Vehicle-Specific Equipment
A4, A4 allroad, A5, A5 Cabriolet, A5 Sportback, A6, A6 allroad, Q5, and Q5 e quattro	2020 – 2022	All	DL 382 Transmission
Q5 Sportback	2021 – 2022

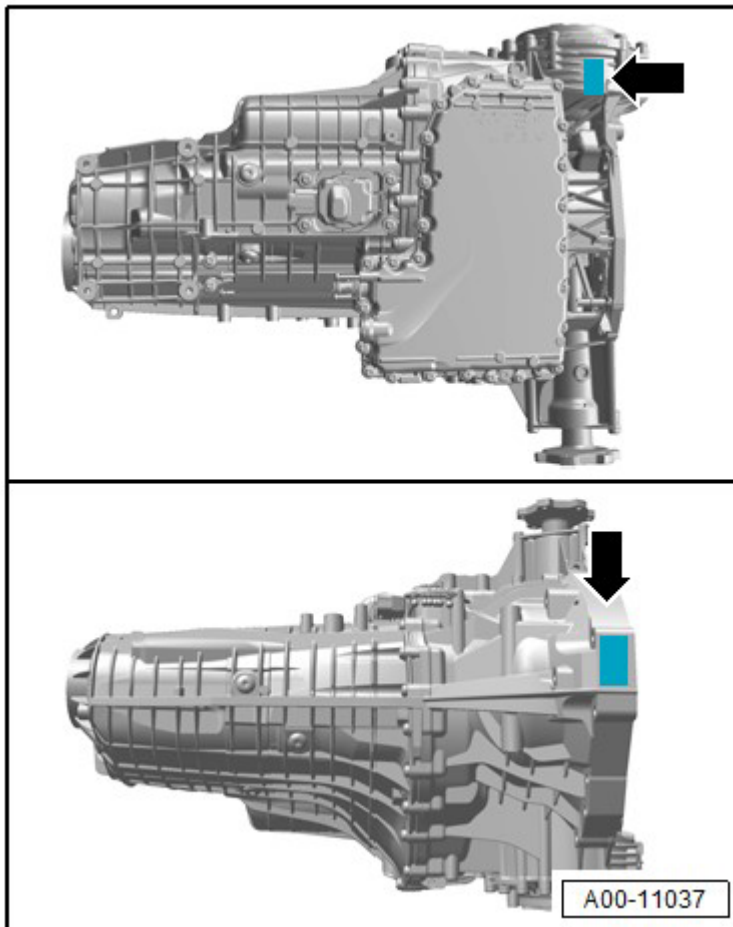
- **First determine if the Transmission was built within the date range of June 15, 2020, and May 31, 2022.**
- Check one of the transmission data stamps which are located on the bottom of the front differential and the top of the bell housing (Figure1).

*Figure 1. Locations of data stampings.*
