# Technical Service Bulletin

42 Booming noise from rear area while vehicle is moving (depending on vehicle speed/wheel speed) DTC P18F100

42 22 50 2068250/1 November 4, 2022.

| Model(s) | Year | VIN Range | Vehicle-Specific Equipment |
|---|---|---|---|
| Q4 e-tron, and<br>Q4 e-tron<br>quattro | 2022 – 2023 | All | Not Applicable |

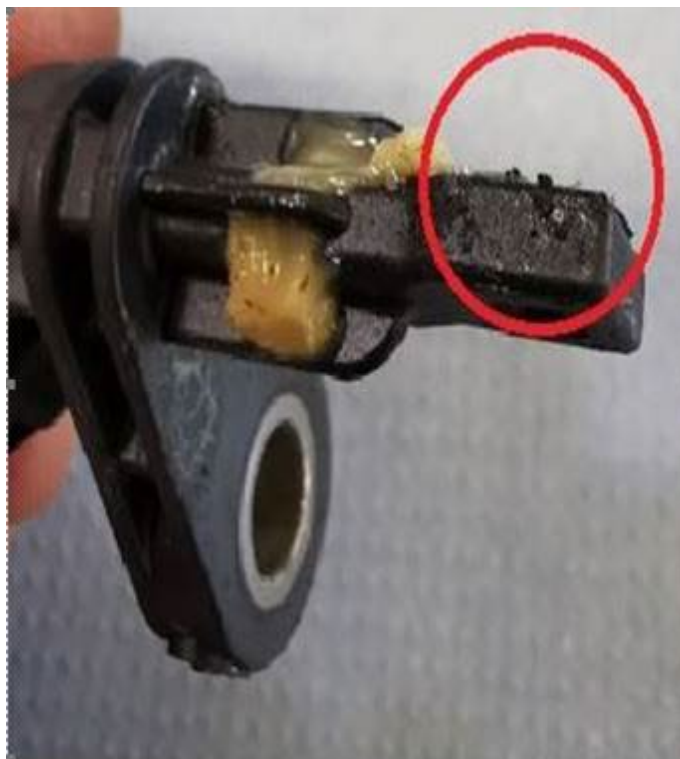
Foreign metallic particles in the area of the wheel speed sensor/wheel hub/wheel bearing/drive shaft (see figure 1, red circle) lead to implausible wheel speed signals.

*Figure 2: Metallic particles in the speed sensor.*

- c. If there are no foreign metal particles, this TSB does not apply.
  - d. Go to Step 2 if foreign metallic particles are found.
2. **Remove foreign metallic particles, check components for damage, and replace components if necessary.**

- a. Thoroughly remove foreign metallic particles from the components with workshop materials.
-

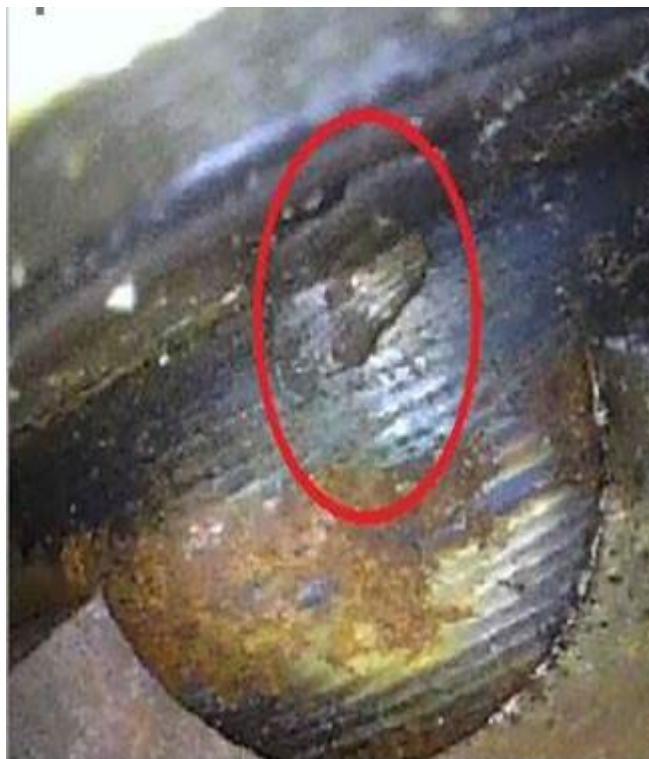
*Figure 3: Metallic particles in the hub.*

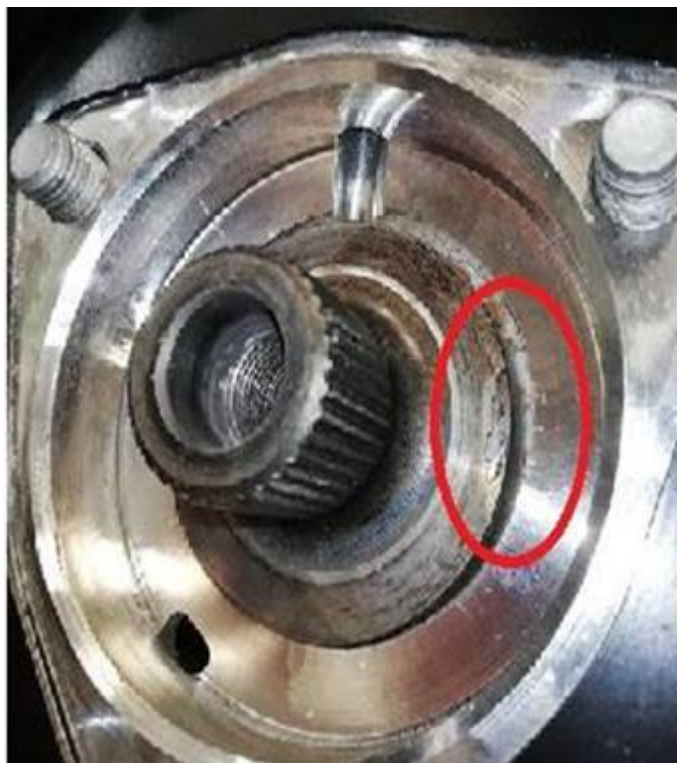
*Figure 4: Metallic particles/damage in the wheel hub/bearing.*

- b. Delete DTCs.
4. **Replace components (if necessary):**
- a. If there is damage to the components, replace them according to the Repair Manual (only if necessary).

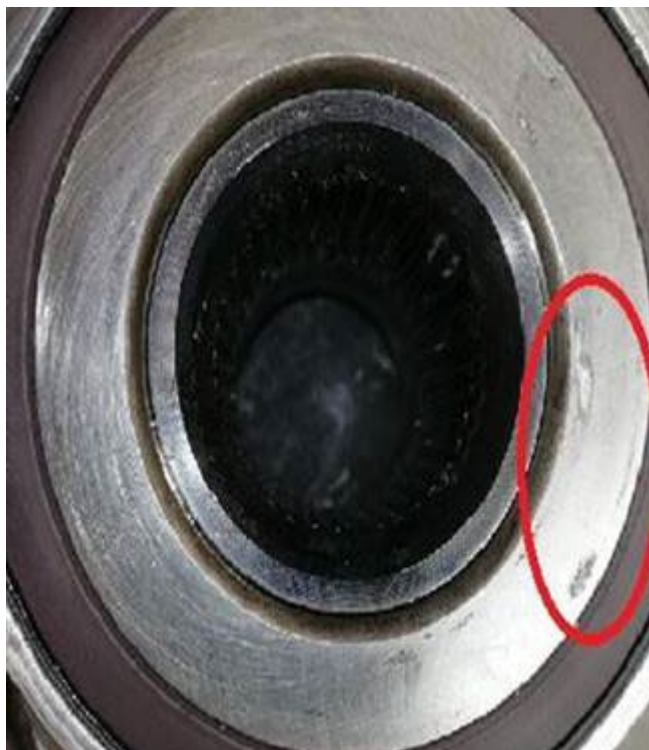
*Figure 5: Metallic particles/damage in the wheel hub/bearing.*
