Published date: 10/3/2022

Preliminary Information

PIP5881 Transmission Overheat Shudder Lack Of Power From A Launch - DTC P054F

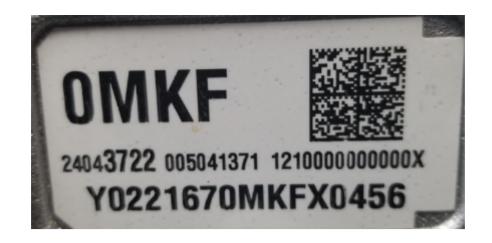
** With a transmission build dates between January 3,2022 (Julian Date 003) and April 4,2022 (Julian Date 094).

Using the picture above as a guide.

Calendar Year – third and fourth digits should be 22

Build Date – fifth, sixth and seventh digits should be between 003 and 094 **

Replacement of the Torque Convertor and Transmission filter will be required.
