Bulletin No.: PIT5887A  
Published date: 10/4/2022

### PIT5887A Diagnostic Aid: Intermittent Vehicle Powers Up But Will Not Crank

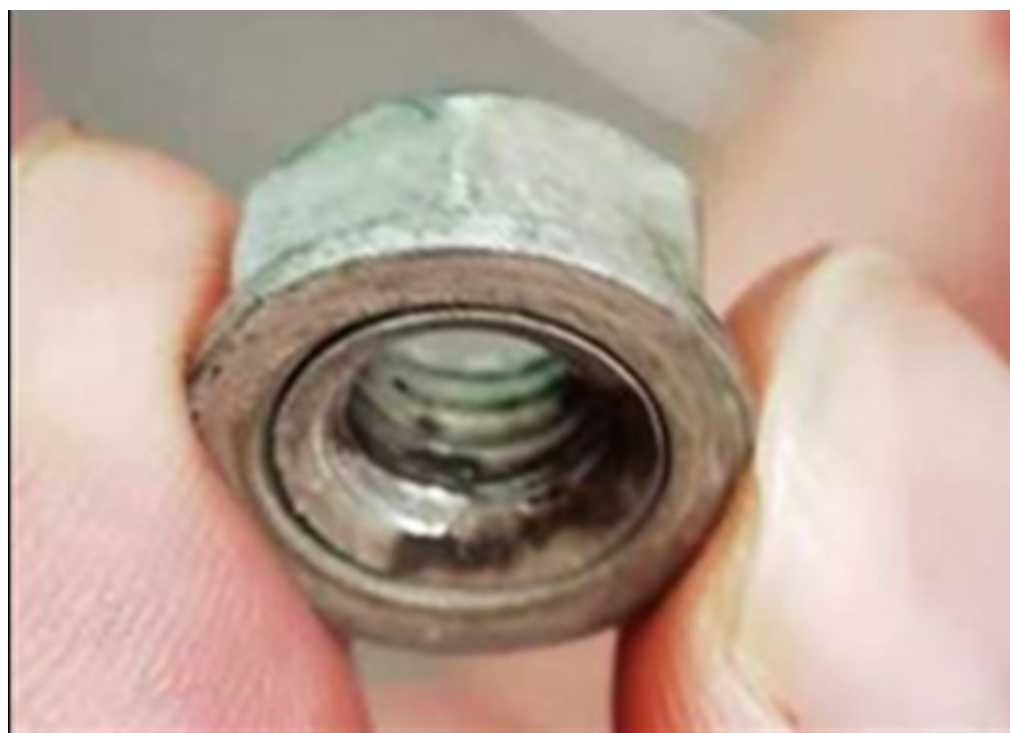
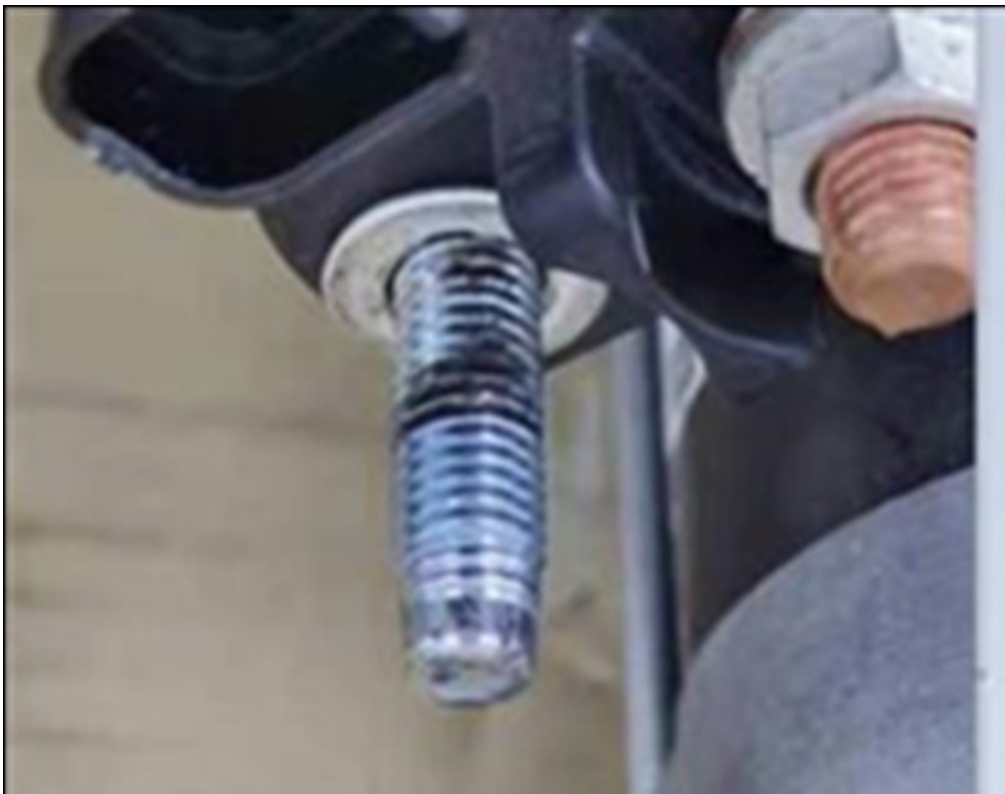
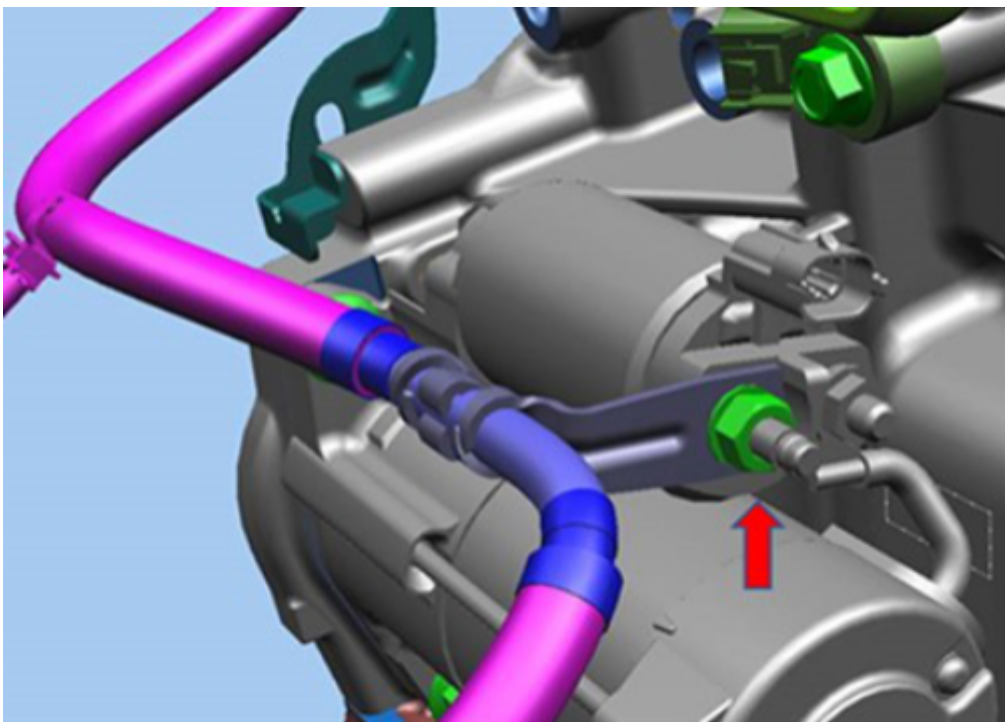
Involved Region or Country:	North America
Condition:	Intermittent No Crank. Vehicle Powers Up Normally.
Cause:	Oxidized B+ Nut or Stud On The Starter Solenoid.

If present, inspect the B+ stud on the starter for oxidation as shown below.

If it's oxidized as shown in the photos, you should replace the nut and clean the stud terminals and re-check starter function.
