Preliminary Information

PIT5897A Radio Display Concern – No Content Available Displayed
Models

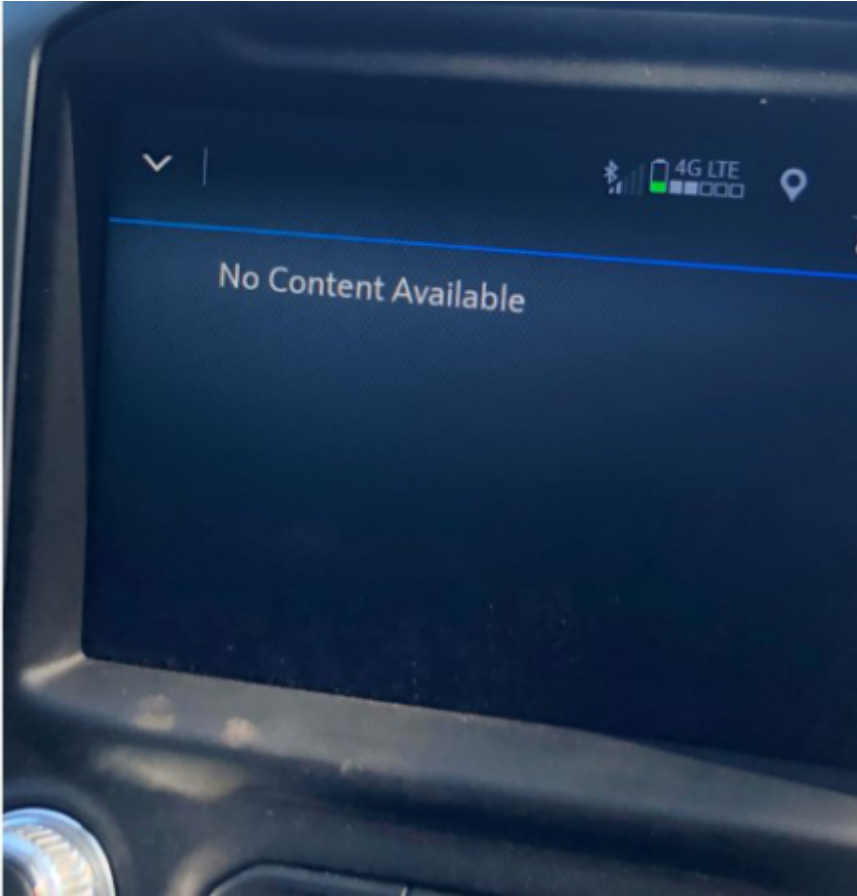
Involved Region or Country	United States, Canada, Mexico, Middle East, Israel, Palestine, Chile (West), Paraguay (West), Uruguay (West), Thailand (ASEAN), Australia/New Zealand
Additional Options (RPO)	IOR
Condition	<p>Some customers may comment that the radio display screen (8" display only) will randomly flip to a "No Content Available screen" or notice that the display screen changes at random. The display can become inoperative and then back to the "No Content Available" screen.</p>

Cause	The cause of the condition may be issues related to the radio display.

Do not replace the radio for this particular concern. Dealers are asked to replace the display while engineering works on a fix.
