Preliminary Information

PIT5847G SES Light - Reduced Power - DIC Warning Messages - Reduced Steering Message - Stabilitrack Message

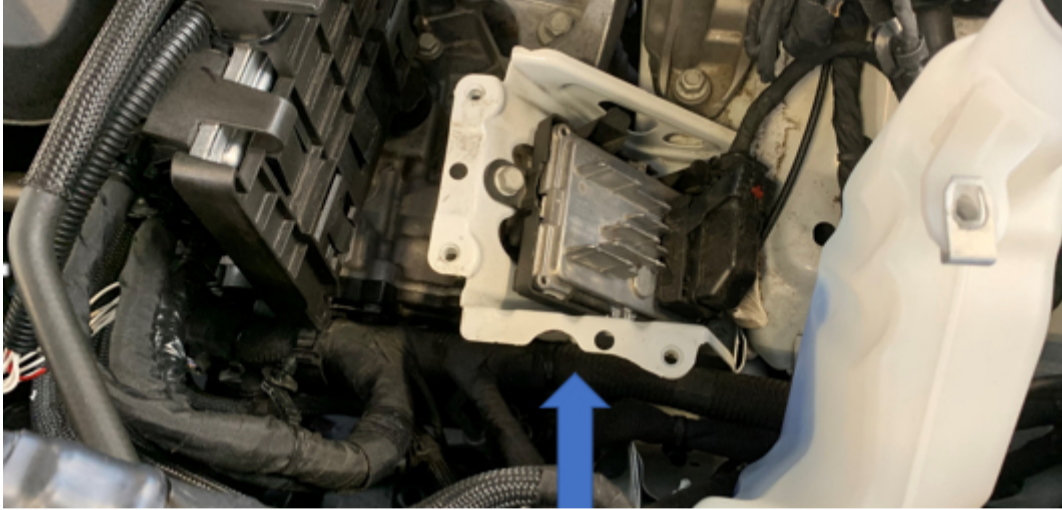
| Cause | <p>Wiring harness rubbing on the battery tray support bracket which secures the TCM. (see photos below)</p> <p>The harness may also rub on one of the studs that secures the top of the control valve body cover.</p> <p>The harness may also rub on a bracket securing the transmission cooler line. (see photos below)</p> <p>The harness may chafe through causing damage to various circuits.</p> <p>Codes and symptoms will vary depending on which circuit or circuits are damaged.</p> |

Battery and battery tray are removed to show the area of concern.

It will be necessary to remove the battery and battery tray to perform the repairs.

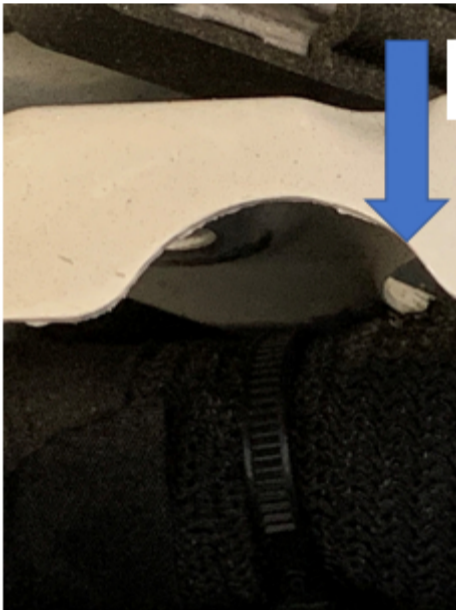
Close up of area where harness may chafe.

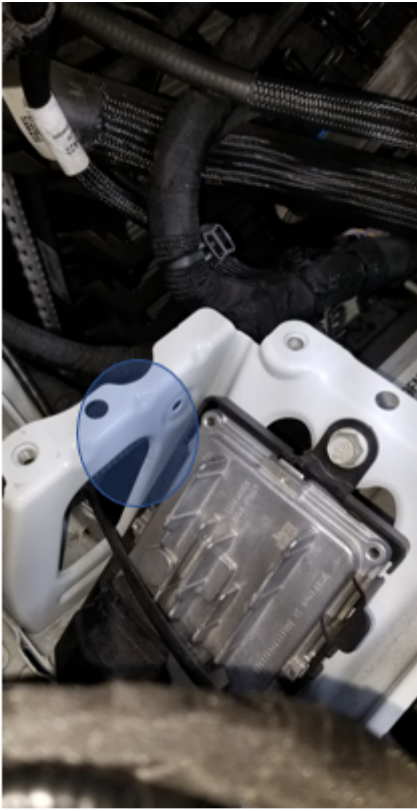
Harness may chafe in the areas shown in the photos above and below.

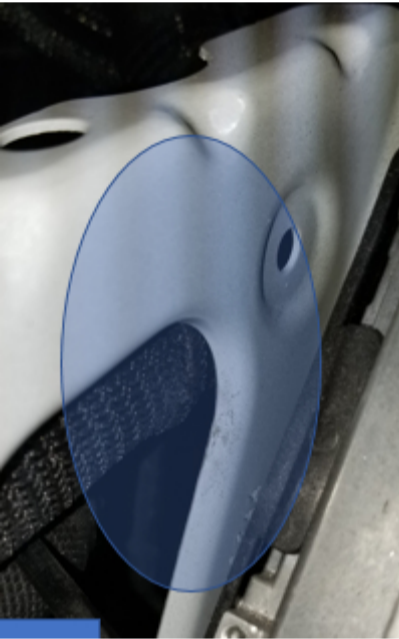
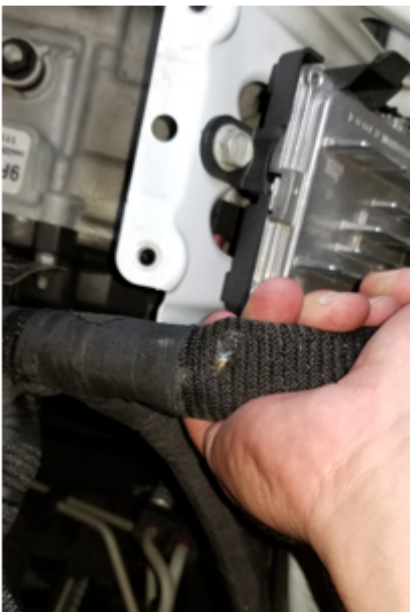
Above shows a harness that was chaffed by the bracket.

If damage is found repair any damaged circuits and tape up the harness.

Reroute or properly secure the harness to prevent further damage.

It may also be necessary to install a piece of heater hose, conduit or both over the harness to prevent a reoccurrence of the concern.

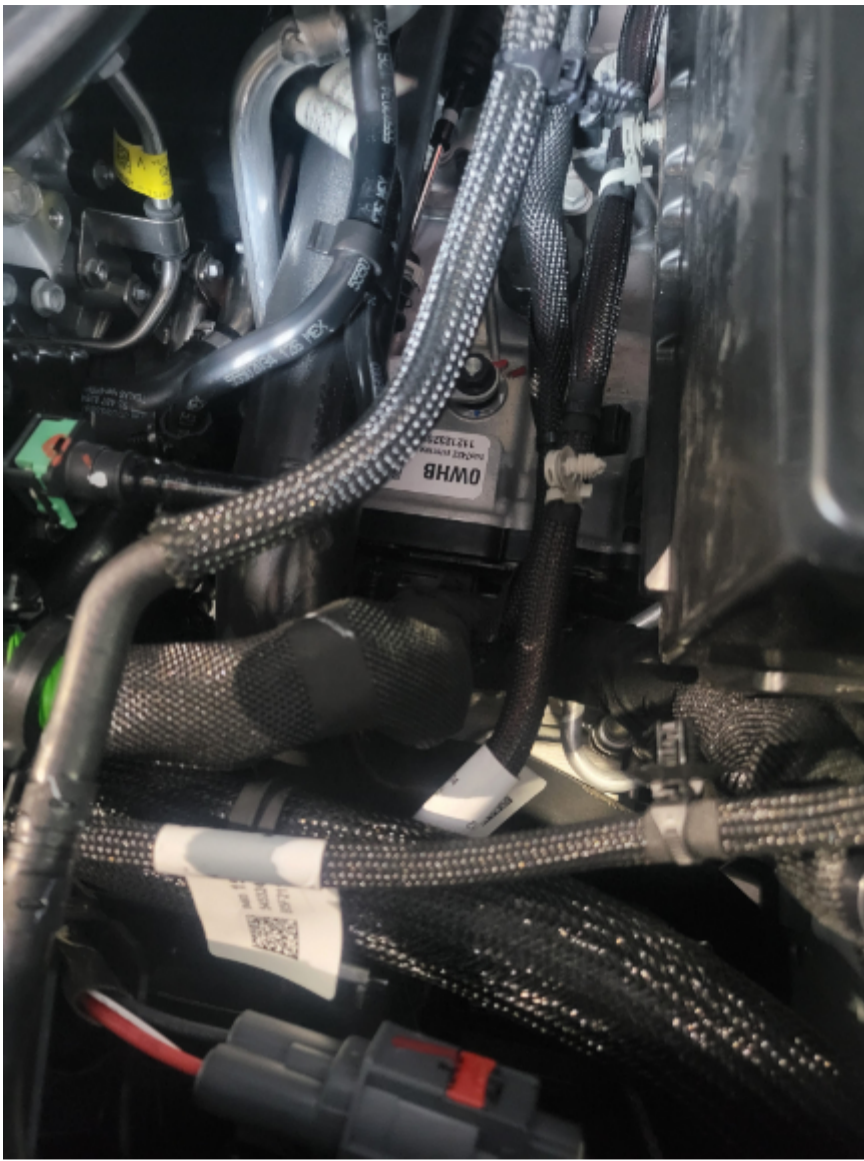
If no damage is found in that area follow the harness over to the area at the top of the control valve body cover. Inspect for damage to the harness caused by one of the studs securing the cover. Inspect area near transmission cooler line bracket as shown below.

Close up of area where harness may rub.
