# Preliminary Information

## PIP5872 10L80 Fluid Leak At the Rear Of the Transmission

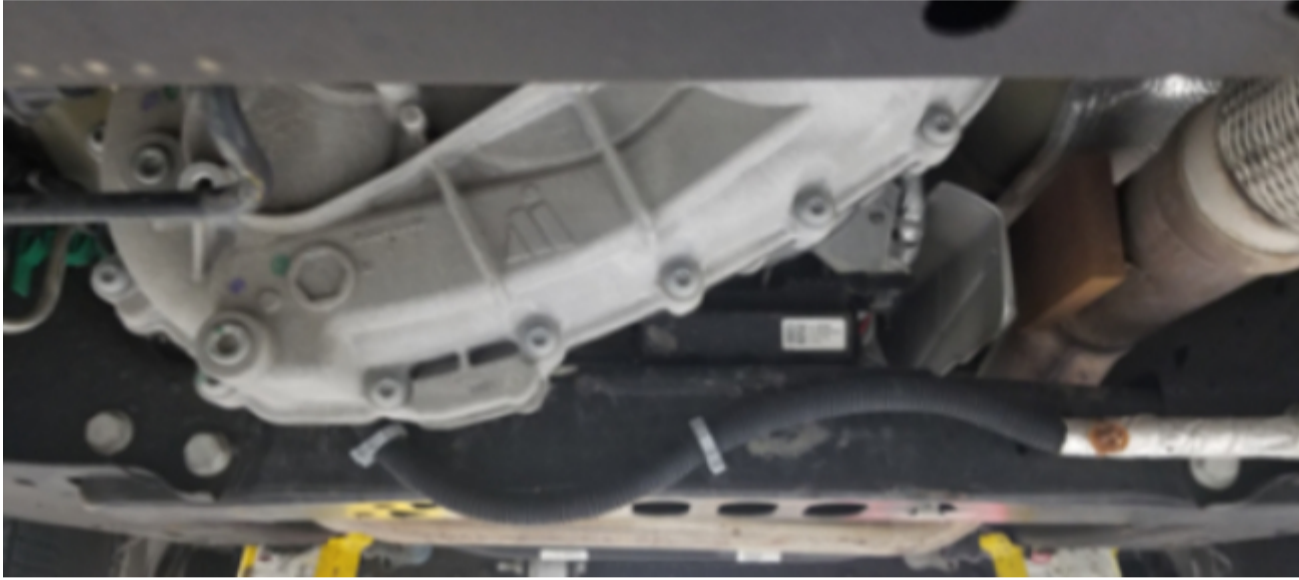
Involved Region or Country	North America & NA Exports
Condition	Some customers may comment that transmission fluid is leaking under the vehicle.
Cause	One or more of the transmission rear case plugs maybe leaking. Use a light looking from the ride side of the transmission between the transmission cross member and transmission case to help confirm the leak source is the case plug.

**4wd shown but 2wd is similar**

**If it is determined that the one or both case plugs are leaking use SI to remove the transmission cross member support and mount to gain access to the plugs.**
