Preliminary Information

PIP5651G Possible Charge Air Cooler Outlet Hose Disconnected From Throttle Body And One or More of The Following DTCs P0172, P0299, P0101, P0506, P1101

Models

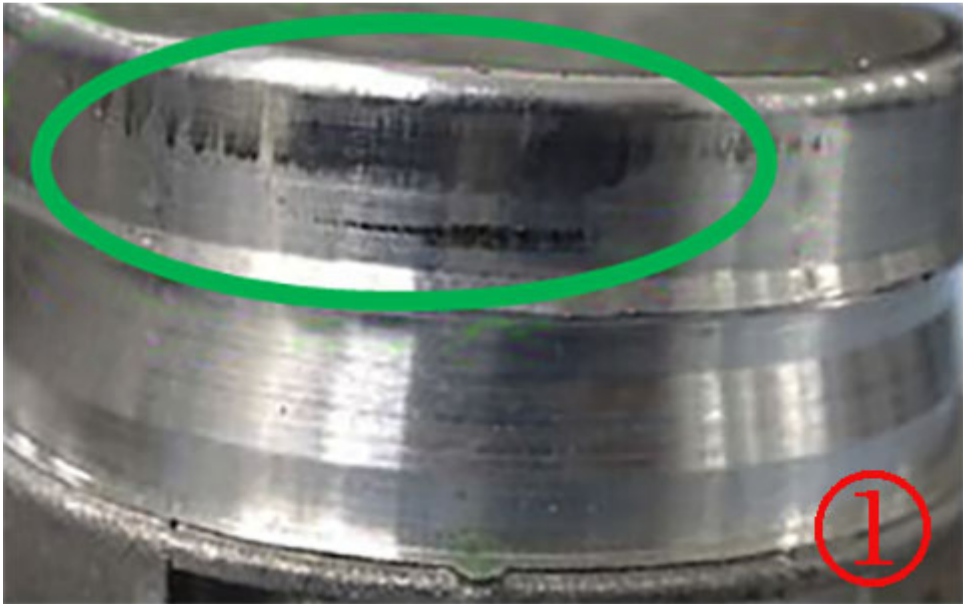
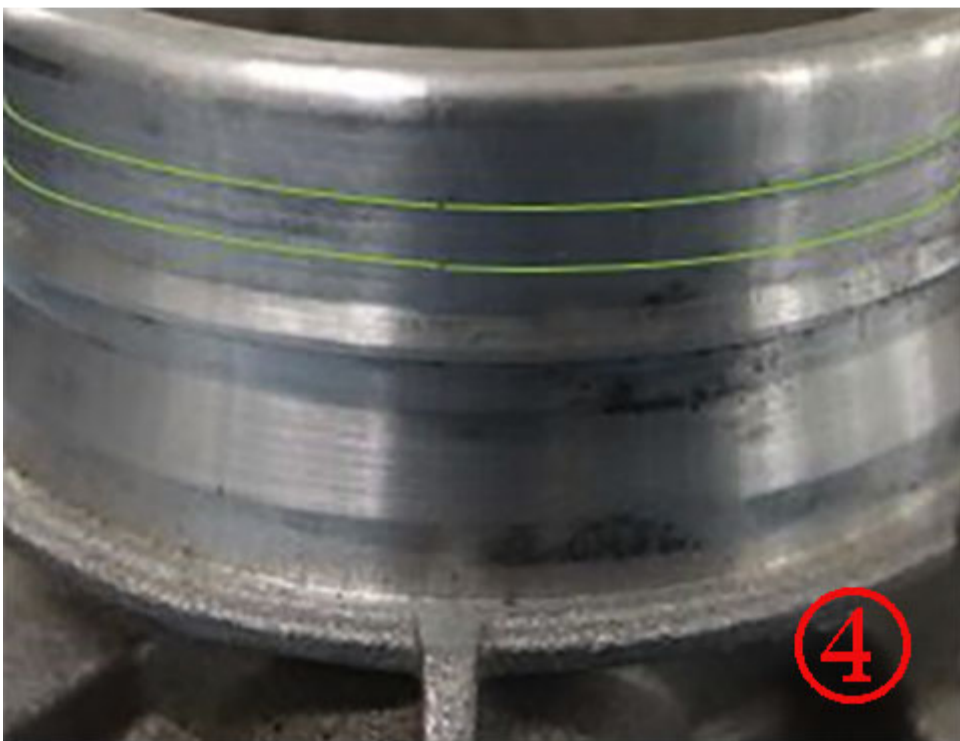
Photos 1-4 below show normal witness marks on the throttle body and normally will not require replacement.
