GROUP	MODEL
BOD	2022-2023MY Sorento (MQ4a) 2023MY Sportage (NQ5a)
NUMBER	DATE
312	November 2022

TECHNICAL SERVICE BULLETIN

SERVICE ACTION: MULTI-POINT TRIM INSPECTION AND REPLACEMENT (SA516)

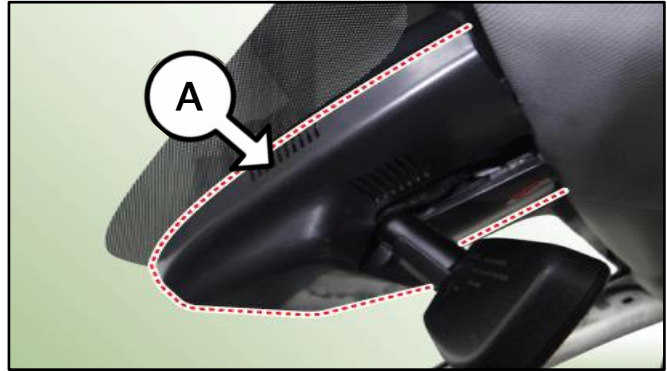
1. Inspect the multi-sensor cover (A) and confirm it is not loose and is mounted flush against the windshield surface.
 - Multi-sensor cover is not loose (OK), no further action is required.
 - Multi-sensor cover is loose (NG), proceed to Step 2.

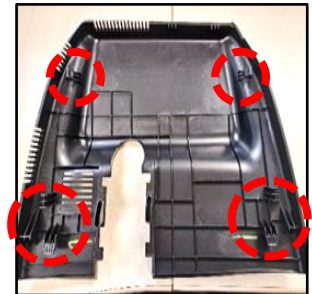
Inside view of covers. (NQ5a and MQ4a)

3. Inspect the multi-sensor cover (A) for broken clips and/or deformation of the outer mounting area to the windshield.
 - Damage/deformation is not present, then reinstall the multi-sensor cover (A).
 - Damage/deformation is present, then replace the multi-sensor cover (A).

If after reinstallation the multi-sensor cover (A) is loose and is not mounted flush against the windshield surface, replace the cover with a new part.

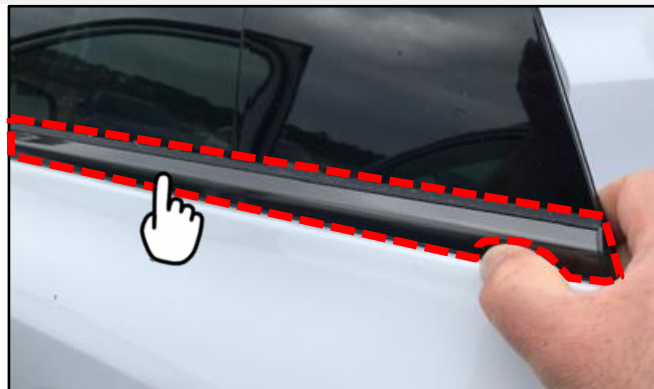
1. Inspect the four (4), front and rear door belt outside weatherstrips for loose fitment.
2. Using your finger, apply upward pressure on the weatherstrip to confirm it is properly secured to the door.

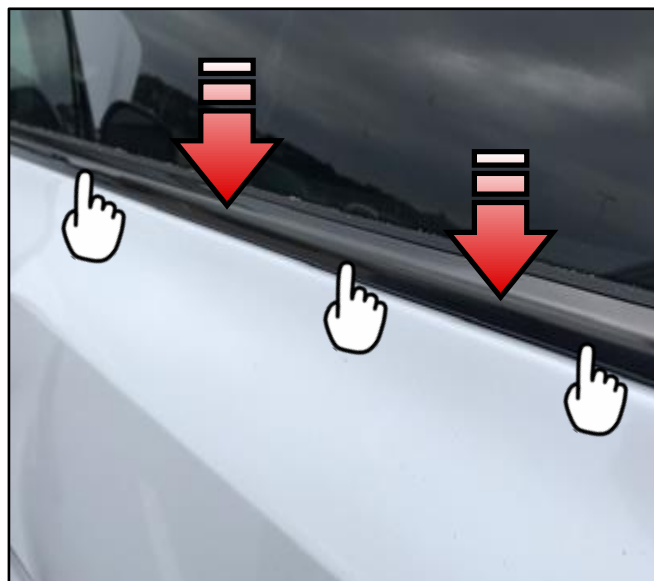
- The weatherstrip is secured flush and not loose (no visible gaps) **(OK)**. No further action required.
- The weatherstrip is not secured flush and is loose (visible gap) **(NG)**, then attempt to clip the weatherstrip down onto the door to secure it.

If the weatherstrip(s) will not secure/lock into door(s), then replace the belt outside weatherstrip on the affected door(s) ONLY by referring to step(s) 3a and/or 3b.

- 3a. To replace the front door belt outside weatherstrip refer to the "Body (Interior and Exterior) → Front Door → Front Door Belt Outside Weatherstrip → Repair procedures" chapter in the applicable Shop Manual on KGIS.
- 3b. To replace the rear door belt outside weatherstrip refer to the "Body (Interior and Exterior) → Rear Door → Rear Door Belt Outside Weatherstrip → Repair procedures" chapter in the applicable Shop Manual on KGIS.

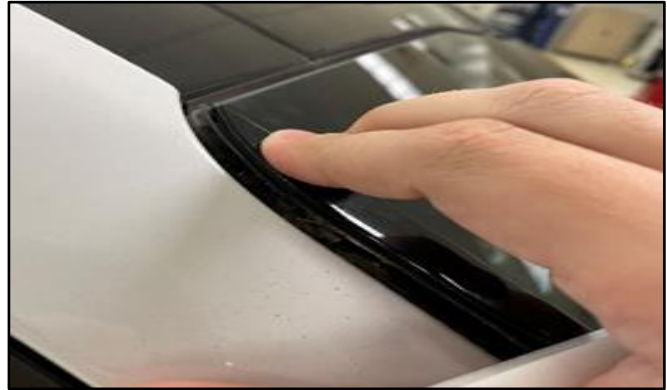
1. Inspect the two (2) front windshield garnish moldings (Left and Right side) for loose fitment.

- The windshield garnish molding is secured flush and not loose (no visible gaps) (OK). No further action required.

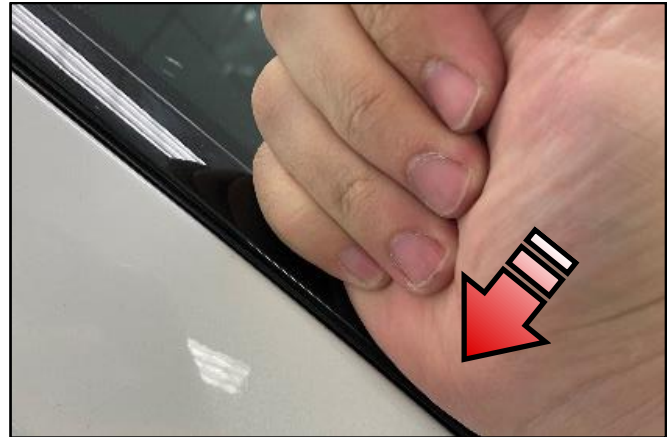
- The windshield garnish molding is not secured flush and is loose (visible gap) (NG), then attempt to clip/secure the weatherstrip trim to the body (outer A-pillar) to secure it by hitting down with a closed fist.

If the front windshield garnish molding(s) will not secure/lock to body, then replace the windshield molding on the affected side (LH or RH) ONLY by referring to steps 2-3b.
